Date: July 9, 2001

Model: BKM-24N

Subject: LIGHT BLUE AT B/W SIGNAL
 RECEPTION

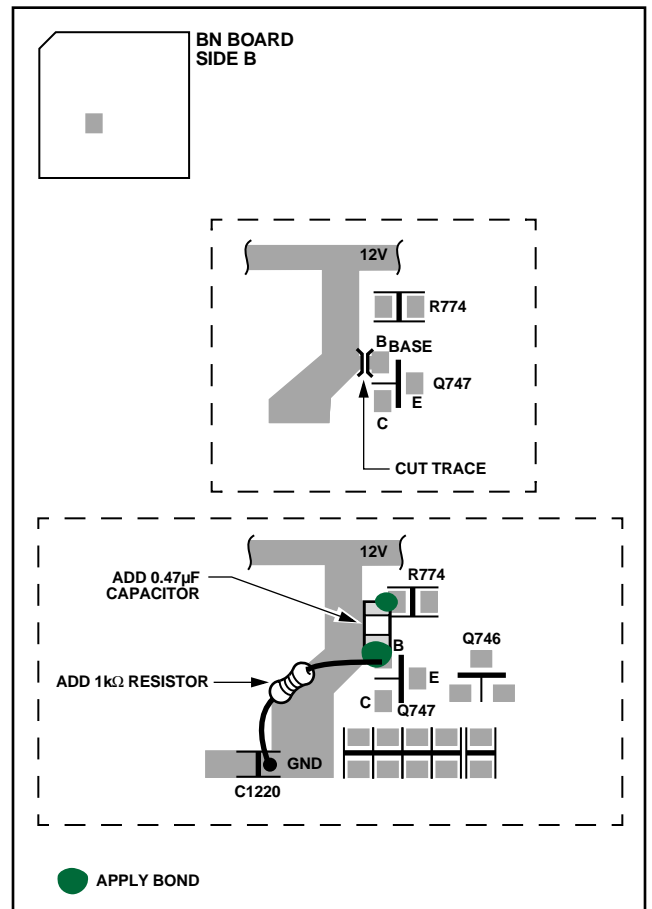
Figure 1

When receiving a black and white NTSC signal with burst, if the MONO switch is turned on and off in a dark scene, ripples from the power line may enter the B-Y signal in the B-Y amplifier, causing a change of color temperature in the RGB matrix circuit. If this occurs, perform the following modification procedure.

BN Board, Side B (See Figure 1.)

1. Remove the shield plate from the back of the BN board.
2. Cut trace leading from the base of Q747.
3. Solder a 0.47 μ F/16V chip capacitor between the base of Q747 and the 12V bus of R774.
4. Solder a 1 k Ω resistor between the base of Q747 and the ground of C1220.
5. Apply Sony bond as indicated.
