Subject: **ELONGATION OF VERTICAL SIZE WHEN
 CCIR INPUT IS USED**

Model: **PVM-95**

Serial No: **1,000,304–1,001,283**

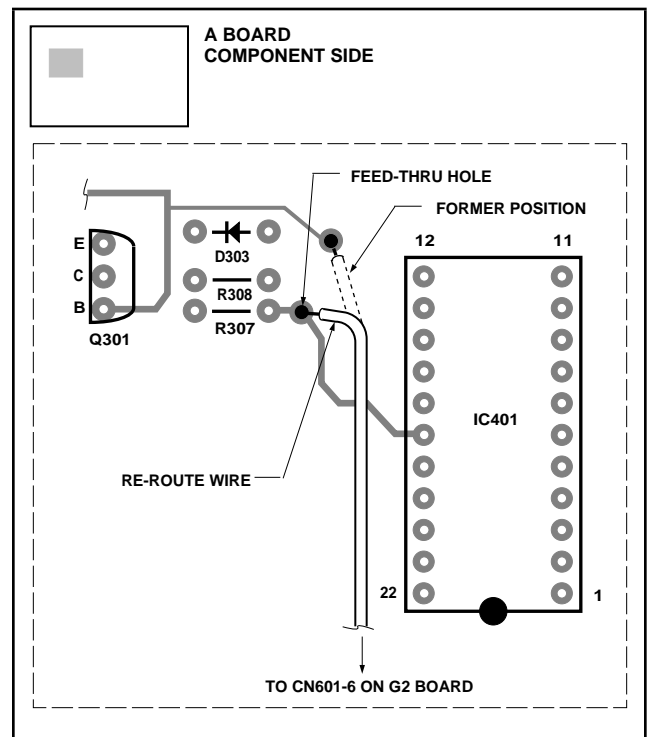
Figure 1

In some of the above units, vertical picture size may be lengthened by approximately 20% when a CCIR signal is input. To correct this condition, perform the following modification procedure.

**A Board, Component Side
 (See Figure 1.)**

1. Remove wire from Q301-B and re-solder it at the feed-thru hole near IC401-17 as shown.
2. Adjust RV301 (V. SIZE). (Refer to Service Manual, page 10.)

NOTE: After rewiring, vertical size may be lengthened by approximately 30% when EIA signal is input. Always adjust RV301 after rewiring.

3. Move the wire from CN601-6 on the G2 board to the feed-thru hole shown in Figure 1.
