**Display**

Subject: **FLICKER, WHITE BALANCE CHANGE**

Model: **PVM-8040**

Serial No: **2,000,001-2,012,000**

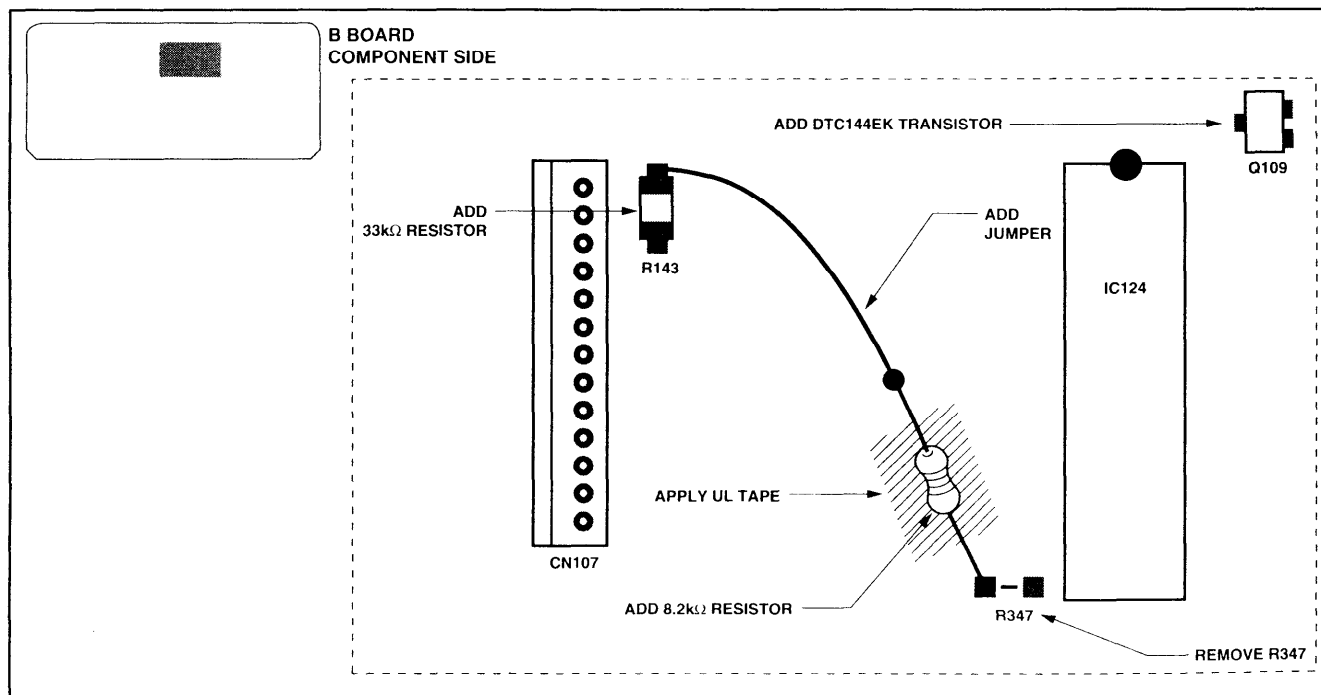
**Figure 1**

At reception of a video signal with VITS, a flicker or undulation of brightness occurs in the picture. When the upper right portion of the video picture is bright, white balance changes. To correct this problem, perform the following modification procedure.

**B Board, Component Side (See Figure 1.)**

1. On upper right side of IC124 (near R129, R369), solder DTC144EK transistor to the Q109 trace.
2. On right side of CN107, solder a 33kΩ resistor to the R143 trace.
3. Remove R347 (lower left side of IC124).
4. Solder 8.2kΩ resistor between R347 and R143 (shown in Figure 1). Add jumper wire for extension.
5. Apply UL tape to 8.2KΩ resistor to protect components.

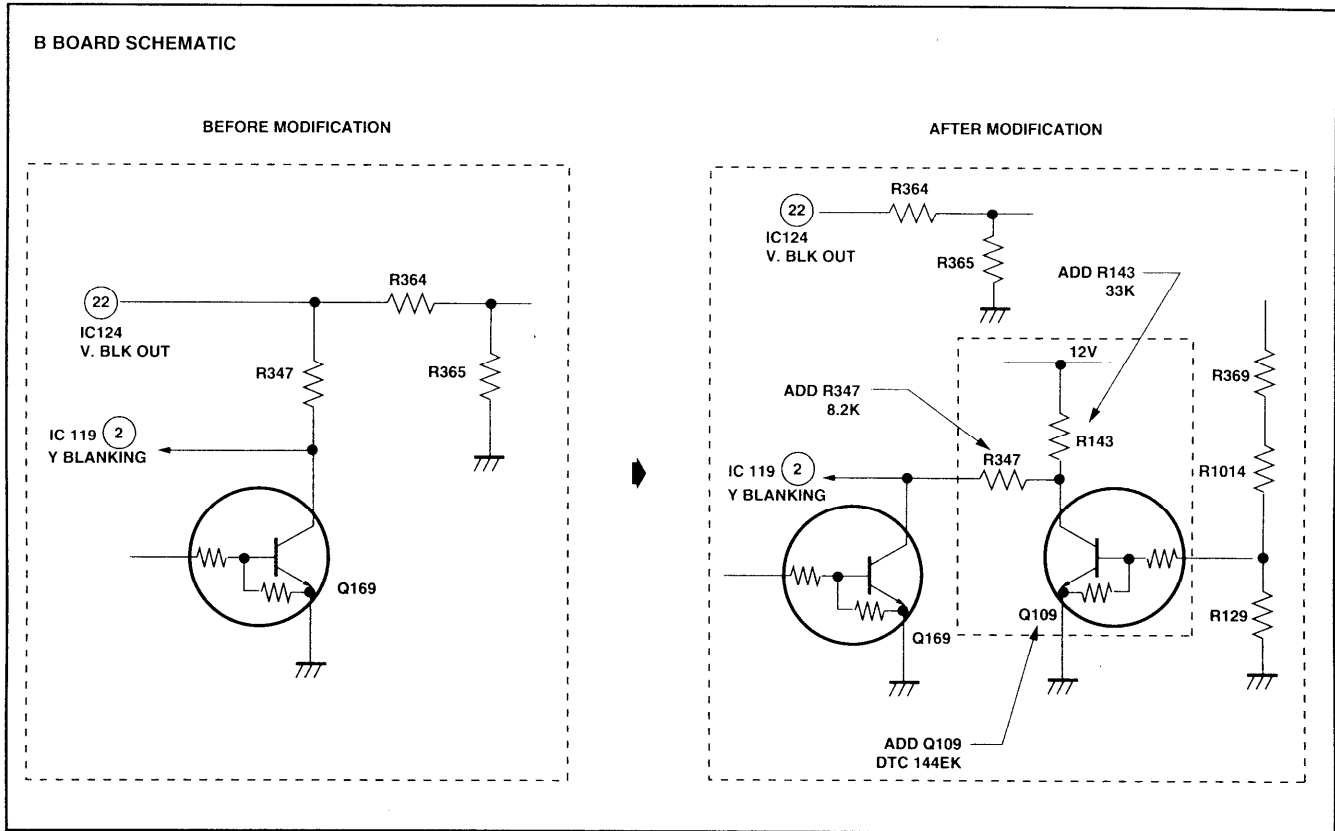
Figure 2

The before and after modification is shown on the B Board Schematic drawing in Figure 2.
