Date: **August 29, 1994**

Subject: **WHITE STRIPE ON RIGHT SIDE OF
SCREEN**

Model: **BVM-1910/1911/1912/2811**

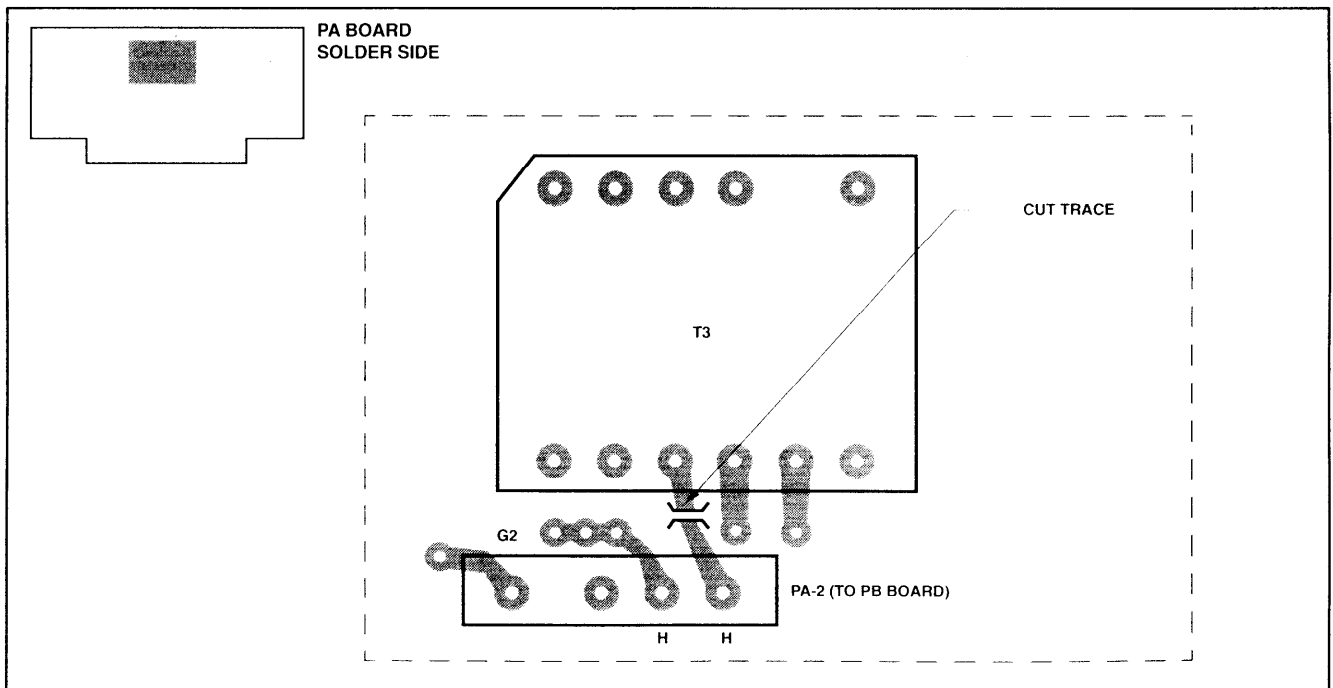
Figure 1

Interference from the LOT transformer and the flyback transformer on the G2 voltage regulator line may cause a white stripe to appear on the right side of the screen. To prevent this condition, perform the following modification procedure.

1. For BVM-1911/1912/2811 units which have C board 1-617-889-13 or higher,* cut trace between transformer T3 and pin 4 of PA-2 connector as shown.

*These boards have a C-9 connector, and JW100 has been removed.
