Date: **November 9, 1998**

Subject: **10% OVERSCANNING MODIFICATION**

Model: **BVM-20E1U, BVM-20F1U**

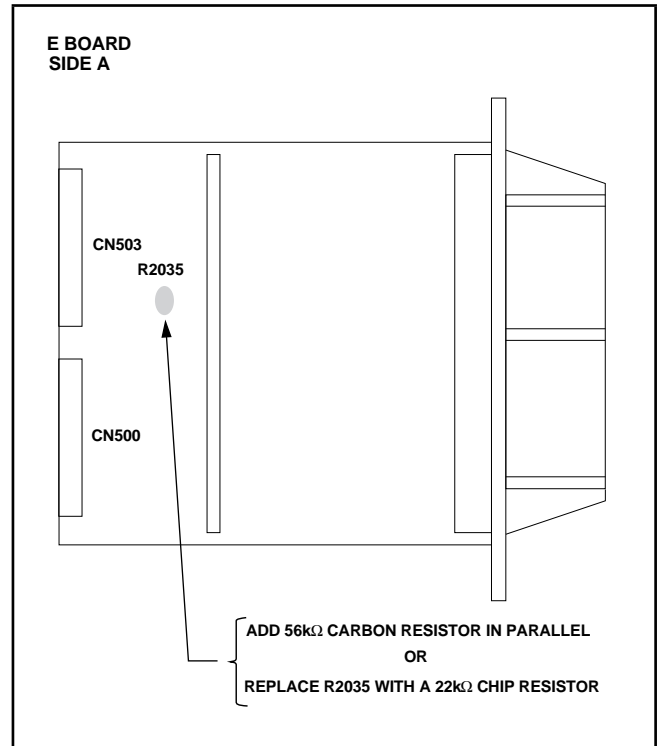
Figure 1

The specification for adjustable range of the scan size is $\pm 15\%$. However due to insufficient blanking, when signal is overscanned by more than 10%, horizontal fold-over may occur. This appears as faint shadows extending from the edge of the CRT screen.

1. Remove the E board.
2. Perform either step a or step b on side A:
 - a. Solder a 56k Ω carbon resistor in parallel with R2035 (33k Ω).
 - b. Replace R2035 with a 22k Ω chip resistor.
3. Reinstall the E board.
4. Turn power ON.
5. Input monoscope signal to adjust scan size.
6. Follow instructions in Operation and Maintenance Manual, 1st Edition, Rev. 1, Page 4-3, "H Blanking Adjustment" section to adjust H SIZE, H BLK PHASE, H CENTER, H PHASE and H BLK WIDTH for 4:3 NORMAL, 4:3 UNDER, 16:9 NORMAL, and 16:9 UNDER.
