Subject: **CORRECTING CLICKING NOISE**

Model: **BKM-102**

Serial No: **2,000,060–2,000,328**

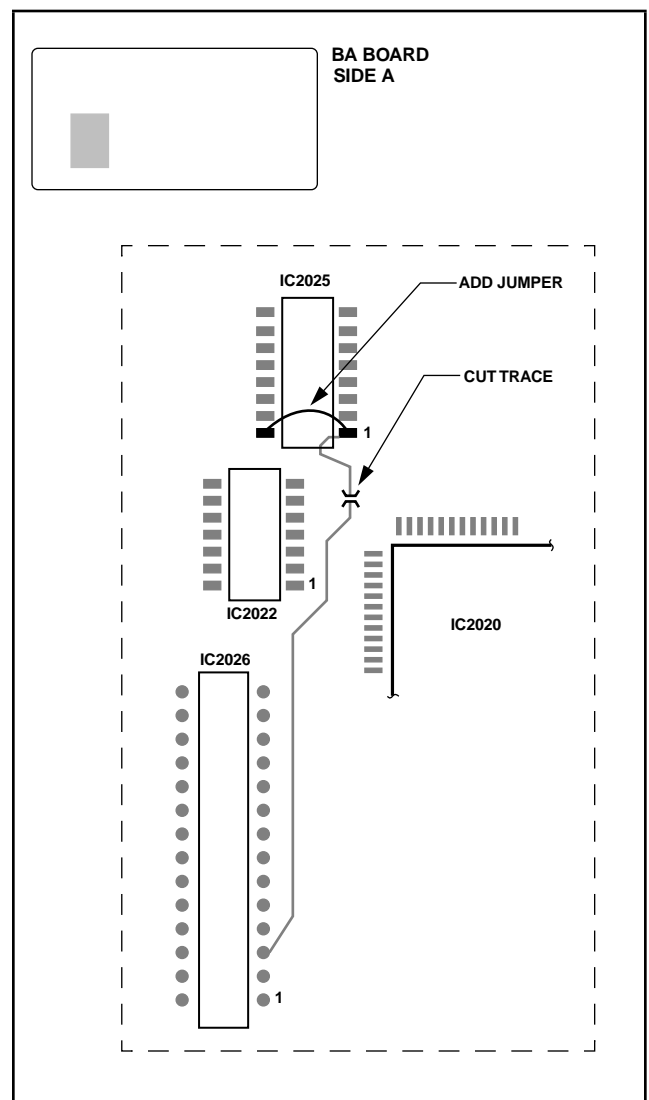
Figure 1

When feeding a signal from Tektronix signal generator TSG-601 to the SDI input of a PVM-1954Q with a BKM-101C/BKM-102 installed, a clicking sound may be heard. To correct this condition, perform the following modification procedure.

1. Cut trace leading from pin 3 of IC2026 (PLD) (zone F-2).
2. Solder a jumper between pin 1 (clear) and pin 16 (+5V) of IC2025 (counter) (zone D-2) as shown in Figure 1.
