Date: **April 4, 1994**

Subject: **SERIAL ERROR AT ACTIVE OUT**

Model: **BKM-2085-14, BKM-2085-20**
DMIF-1000

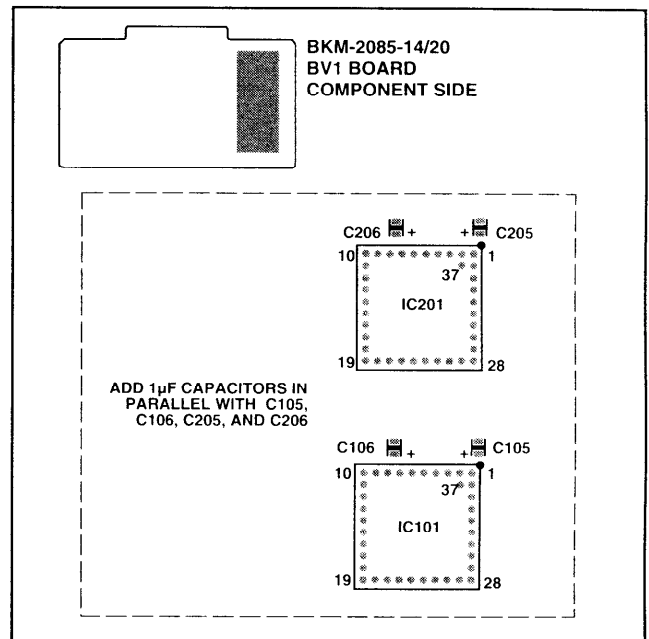
When a video monitor receives a specially coded digital serial input signal, such as an SDI signal, the active output signal sent to additional connected monitors may result in horizontal noise in some monitors. To correct this condition, perform the following modification procedure.

BKM-2085-14/-20
BV1 Board, Component Side
 (See Figure 1 and 3.)

Solder four 1 μ F electrolytic capacitors in parallel with C105, C106, C205, and C206. (Note polarity.)
