Display

Subject: **RESTORING WHITE BALANCE**

Model: **BVM-8044QD, PVM-5041Q, PVM-8040  
 PVM-8041Q, PVM-8043MD, PVM-8044Q  
 SSM-8040**

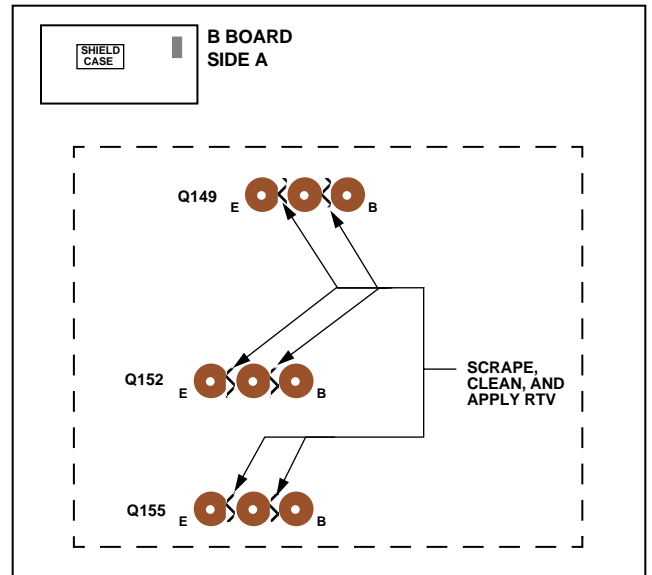
**Figure 1**

If the insulation for transistors Q149, Q152 and Q155 on the B board is insufficient and current leakage occurs, white balance may not be achieved when the CRT is replaced.

**Side A, Zones A-9, B-9 (See Figure 1.)**

1. *Carefully* scrape with knife areas between collector and emitter and between collector and base of Q149, Q152 and Q155 as shown.

**NOTE:** Be careful not to cut any traces in the vicinity.

2. Clean scraped areas.
3. Apply RTV to scraped areas.
4. Readjust white balance.

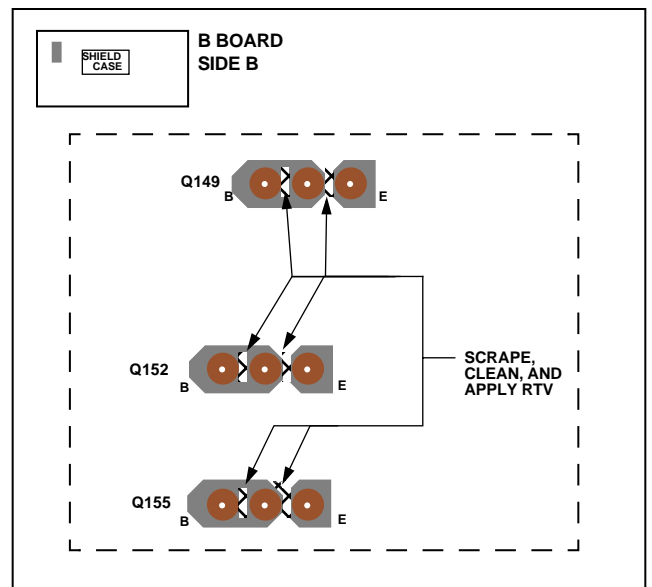
**Figure 2**

**Side B, Zones A-2, B-1 (See Figure 2.)**
