Subject: **D-1 SERIAL INPUT SIGNAL NOISE**

Model: **BKM-2085-14**
BKM-2085-20

Serial No: **2,000,001 AND HIGHER**

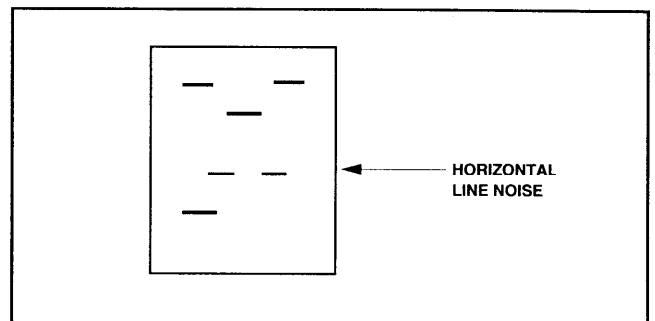
Figure 1

When a serial component digital video input signal is selected, an error at the serial-to-parallel converter may cause horizontal screen noise (see Figure 1). To minimize this effect, perform the following modification procedure.
