# Broadcast Products Technical Bulletin 20-2007-052

SUBJECT: HORIZONTAL LINES SKEWED ACROSS SCREEN

MODEL: **BVM-A14F5A**  
**BVM-A14F5M**  
**BVM-A14F5U**  
**BVM-A20F1A**  
**BVM-A20F1M**  
**BVM-A20F1U**  
**BVM-A24E1WA**  
**BVM-A24E1WM**  
**BVM-A24E1WU**  
**BVM-A32E1WU**  
**BVM-A32EWM**

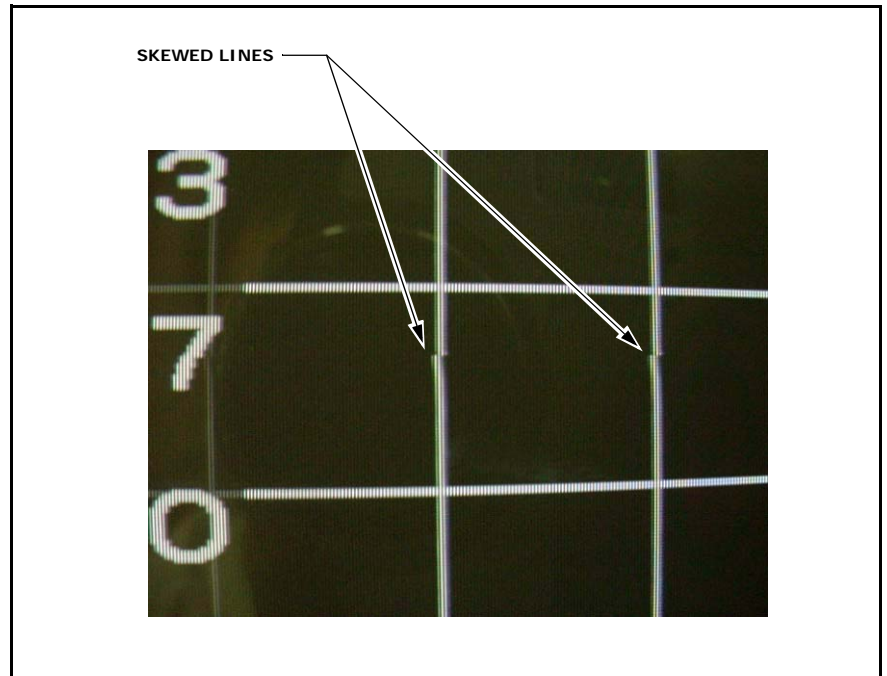
**Figure 1**

When receiving a 720/50P or 720/60P signal, one or two horizontal lines may be skewed across the entire the screen. (See Figure 1.)

The symptom occurs after the unit is warmed up, particularly with BVM-A20F1 units.

Replace R13 (100Ω) with a new 220Ω resistor. (See Figure 2.)

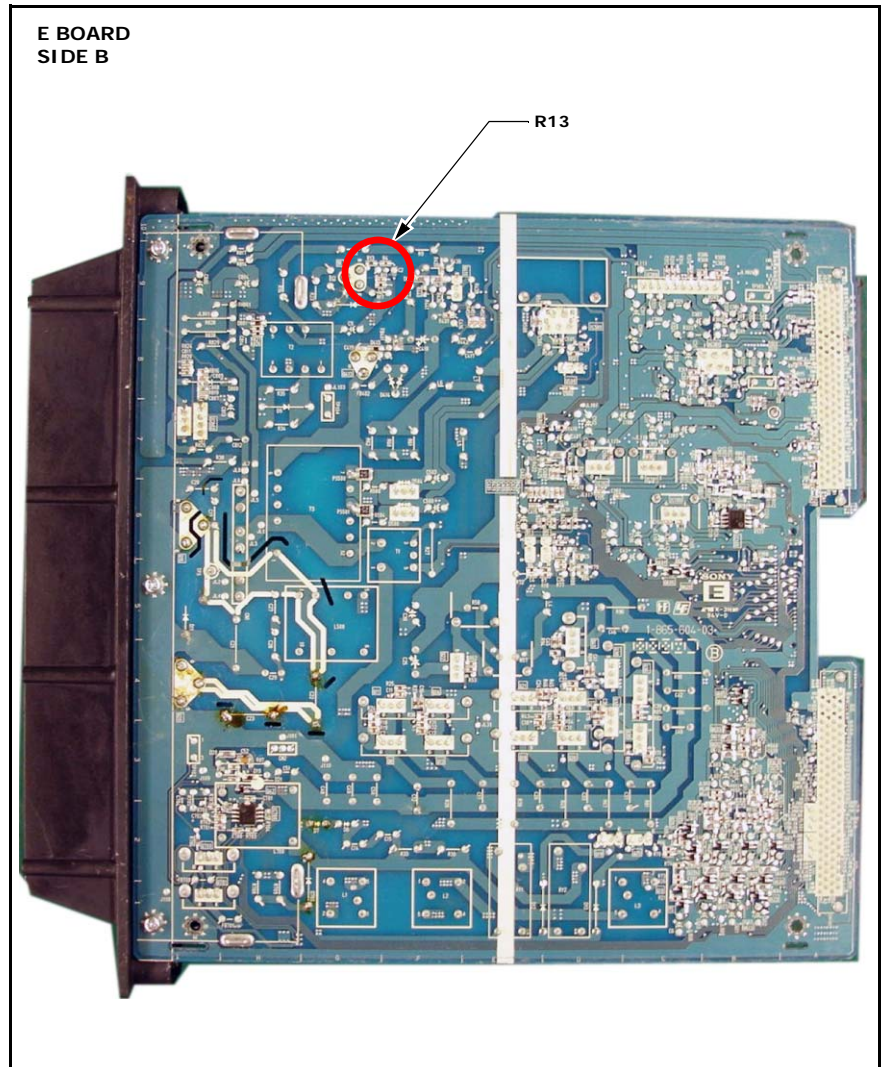
*Figure 2*

### E Board (Side B, Zone F-9)
