Display

Model: **BKM-101C, *BVM-14M4DE***

Subject: **LOSS OF SDI SIGNAL W/B, COMPONENT SIGNAL SHADING**

Serial No: **2,023,651 AND HIGHER (BKM-101C)**
2,012,462-2,013,011 (BVM-14M4DE)

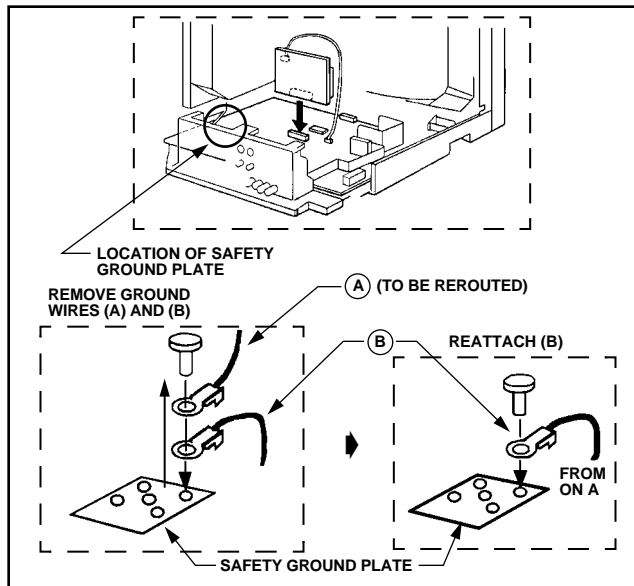
Figure 1

If SDI White Balance is incorrect, or if component signal shading occurs, perform the following modification and adjustment procedures.

1. Remove one screw attaching the following two ground wires to the safety ground (earth) plate.
 - (A) From TP310 on the BB board
 - (B) From PIN308 on the A board
2. Reattach (B) to the safety ground plate.
3. Reroute ground wire (A) as close to the Q board as possible, attaching it and ground wires (C) and (D), from the SDI board, to the bracket of the focus plate.
4. Use two purse locks to secure ground wire (A) to the two cable harnesses between:
 - (A) CN306 (Q board) and CN301 (A board)
 - (B) CN401 (A board) and CN701 (C board)
