**Display**Date: **March 16, 1992**Subject: **HORIZONTAL PICTURE NOISE**Model: **BVM-1912**Serial No: **1,000,001–2,000,152****DESCRIPTION**

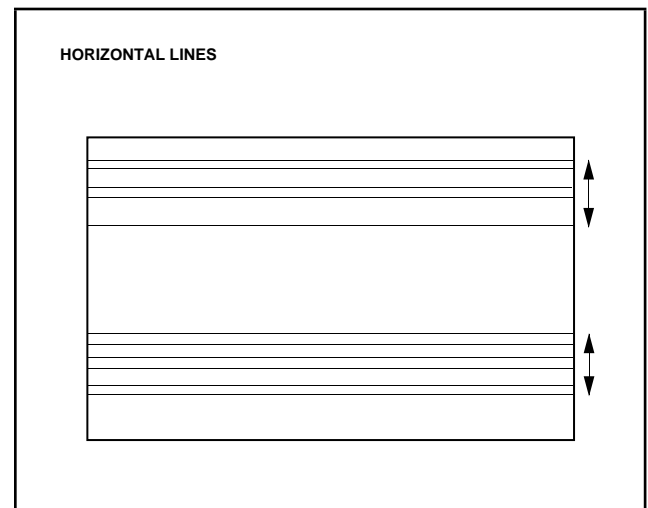
**Figure 1**

Depending on the position in which RV1 on the DD board (pulse width adjustment) is set, occasional crosstalk in the AFC pulse (IC15-1 CK) may occur, and horizontal lines caused by internal oscillation may appear on the screen, moving up and down at random as shown in Figure 1.
