Display

Subject: **WAVEFORM DISTORTION AFTER
 GAMMA MODIFICATION**

Model: *BVM-D24E1WE*, BVM-D24E1WU
BVM-D32E1WE, BVM-D32E1WU

Serial No: **2,000,001 AND HIGHER**

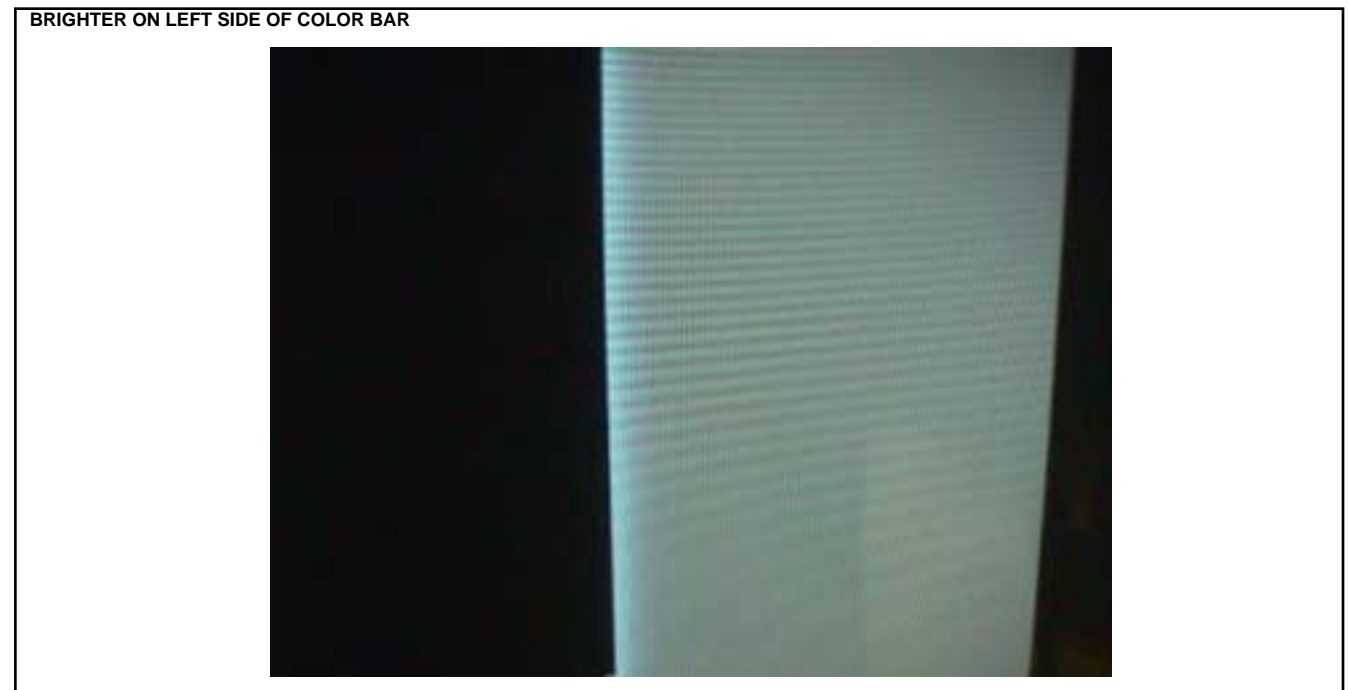
Figure 1

When reducing the brightness in units which have been modified as described in technical bulletin 302001XXX, the following symptoms are visible. (See Figure 1.)

- Input color bars and reduce the BRIGHTNESS control.
Symptom: Left side of each color bar is slightly brighter.
- Set to blue only mode.
Symptom: Left side of bars brighten conspicuously.

To correct this condition, perform one of the following modification procedures, based on the part number silkscreened on the BK Board.
