Video Products Technical Bulletin 30-2002-175R2

DATE: June 1, 2009 SUBJECT: POWER AND HOUT TRANSISTOR FAILURE

MODEL: BVM-D9H1A

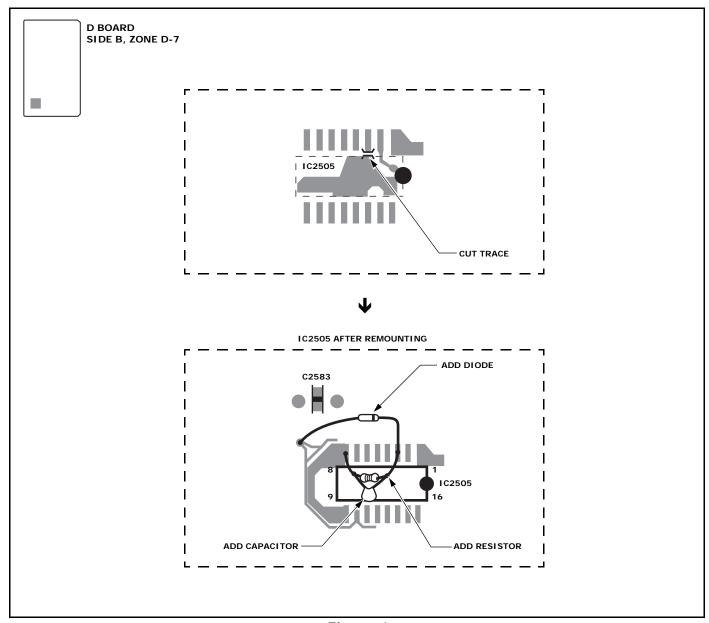
Figure 1

The H OUT transistor may become damaged, resulting in power failure, under the following conditions:

- The BKM-142HD option board is installed.
- The signal cable is pulled out and plugged in, or the signal is cut off after a 720/60p HD-SDI signal is input.

3. Remove C2632 (220 µF), which is soldered in parallel with R2553 (zone B-6).

- 4. Modify the H SYNC circuit on the D board by adding individual components as follows:
 - a. Remove IC2505 (zone D-7).
 - b. Cut the trace leading from IC2505 pin 3.
 - c. Replace IC2505 with a new IC (TC74HC4538AF).
 - d. Solder the cathode of a new diode (1SS119) to IC2505 pin 3.
 - e. Solder the anode of the diode to the thru-hole on the lower left side of C2583.
 - f. Solder a 0.1 μF capacitor between pins 3 and 8 of IC2505.
 - g. Solder a 1 $M\Omega$ resistor to both leads of the capacitor.
