Broadcast Products Technical Bulletin 20-2003-270

DATE: **December 29, 2003**SUBJECT: **GAP BETWEEN MOUNTING BRACKET AND
MONITOR BEZEL IS NORMAL**MODEL: **MB-521//C1**SERIAL NO: **ALL**

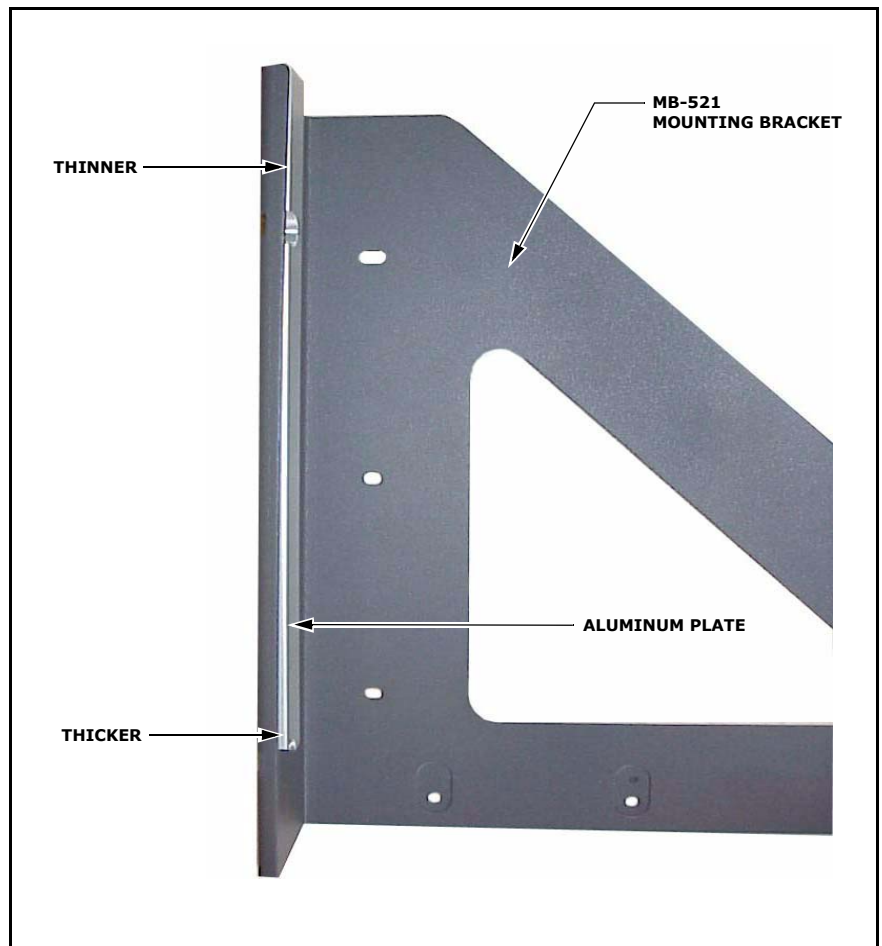
Figure 1

The aluminum plate used to reinforce the edge of the MB-521 mounting bracket varies in thickness from top to bottom by approximately 3 mm. (See Figure 1.)

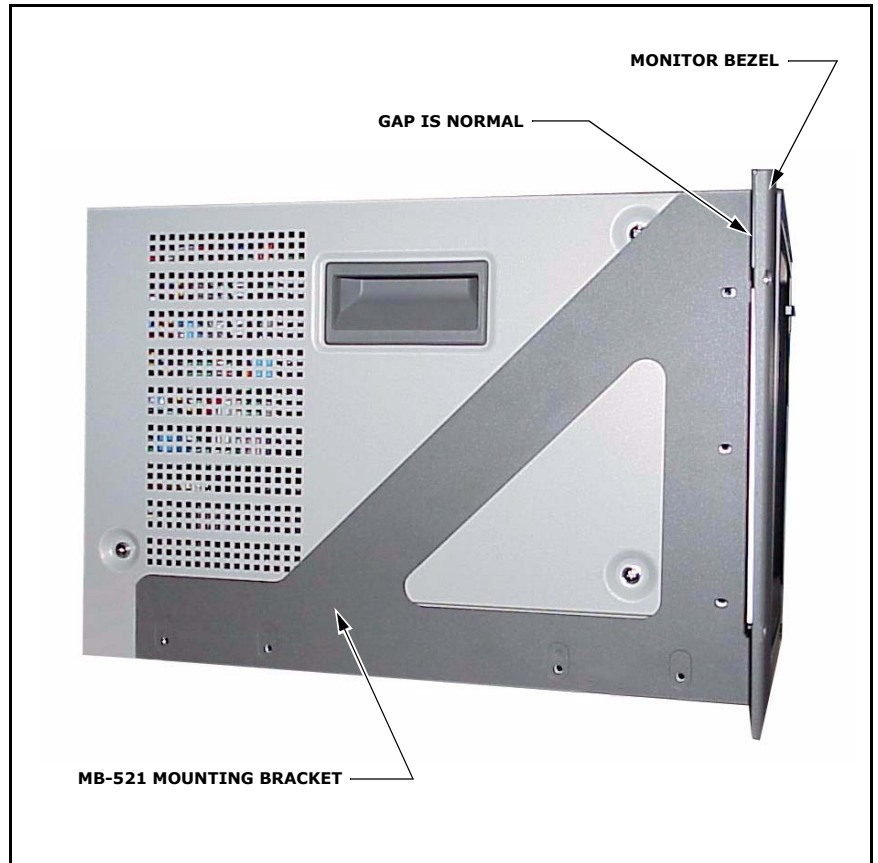
Figure 2

When a PVM-14L5 series monitor is installed to the MB-521 mounting bracket, a gap between the monitor bezel and the bracket causes the monitor to appear slanted. (See Figure 2.)

This gap is normal and is not due to a defective bracket. The gap occurs because of the variation in thickness of the aluminum plate on the bracket.

NOTE: MB-521 brackets with a product code of 90821401 or higher have the varied bracket thickness, which helps lift the rear of the monitor up when installed in an EIA rack.
