Video Products Technical Bulletin 30-2004-002

MODEL: BVM-D14H1A BVM-D14H1E BVM-D14H1U BVM-D14H5A BVM-D14H5E BVM-D14H5U

SUBJECT: VERTICAL LINES WAVE HORIZONTALLY IN UPPER PICTURE

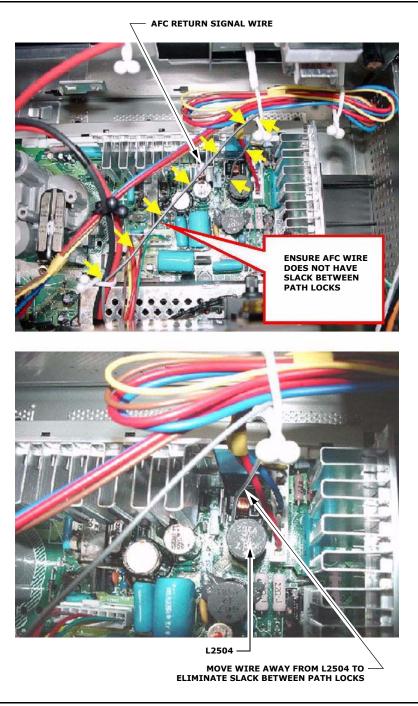
Figure 1

When a 480/60i or 575/50i signal is input in UNDER SCAN mode, vertical lines may wave horizontally in the upper part of the picture.

4. Secure the AFC return signal wire (gray) soldered between L2504 (HLC) and IC515 (PWMIC) so that the wire does not contain slack and is kept away from L2504. (See Figure 1.)

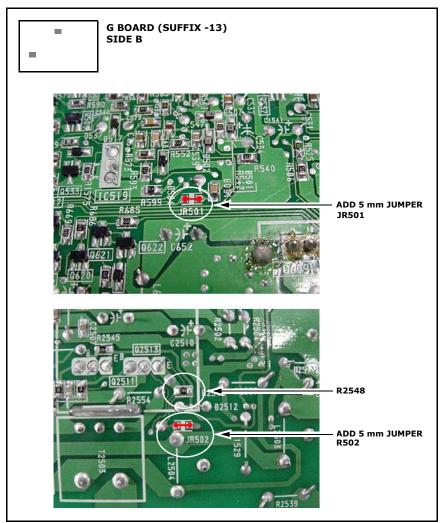
Figure 2

NOTE: A gray AFC wire is not used in suffix -13 G boards. A conductive trace is used instead.

6. Solder a 5 mm jumper to JR501 (near C652) and a 5 mm jumper to JR502 (near L2504) as shown in Figure 2.
