Broadcast Products Technical Bulletin 20-2005-178

SUBJECT: **HIGH VOLTAGE DROPS WHEN HD SIGNAL IS CUT; NO PICTURE DUE TO PROTECTOR OPERATION**

MODEL: ***BVM-D9H1E***
BVM-D9H5A
BVM-D9H5E
BVM-D9H5U

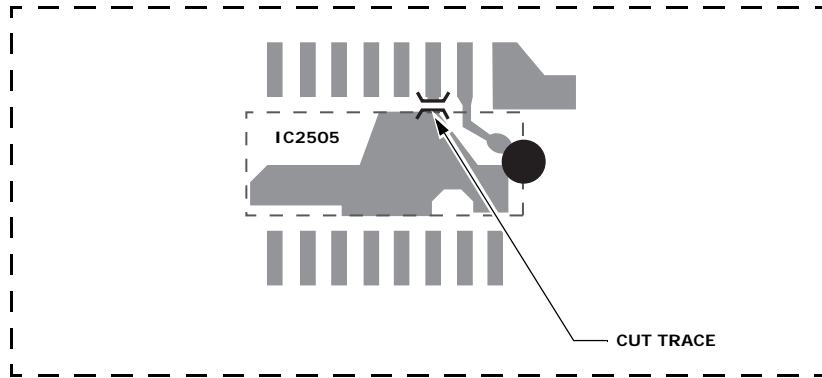
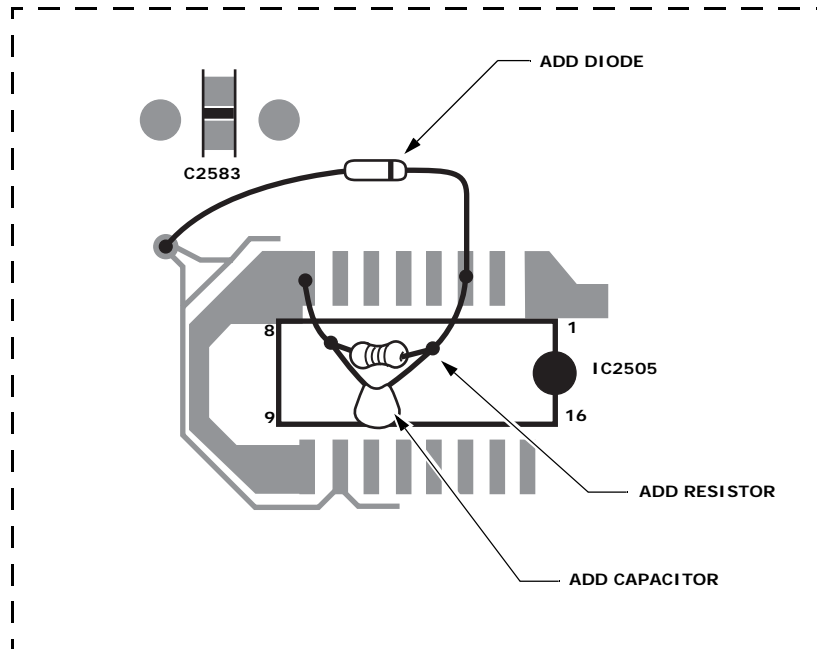
Figure 2

D BOARD
SIDE B, ZONE D-7

IC2505 AFTER REMOUNTING

2. Modify the H SYNC circuit on the D board by adding a piggyback board as follows:
 - a. Remove IC2505 (zone D-7).
 - b. Cut the trace leading from IC2505 pin 3.
 - c. Replace IC2505 with a new IC (TC74HC4538AF).
 - d. Attach a piggyback board to the D board as shown in Figure.
 - e. Affix the piggyback board to the D board with RTV.
