Monitor

Date: **October 22, 2001**

Subject: **NO RASTER**

Model: **PHM-20M8U, *PVM-20M7MDE***

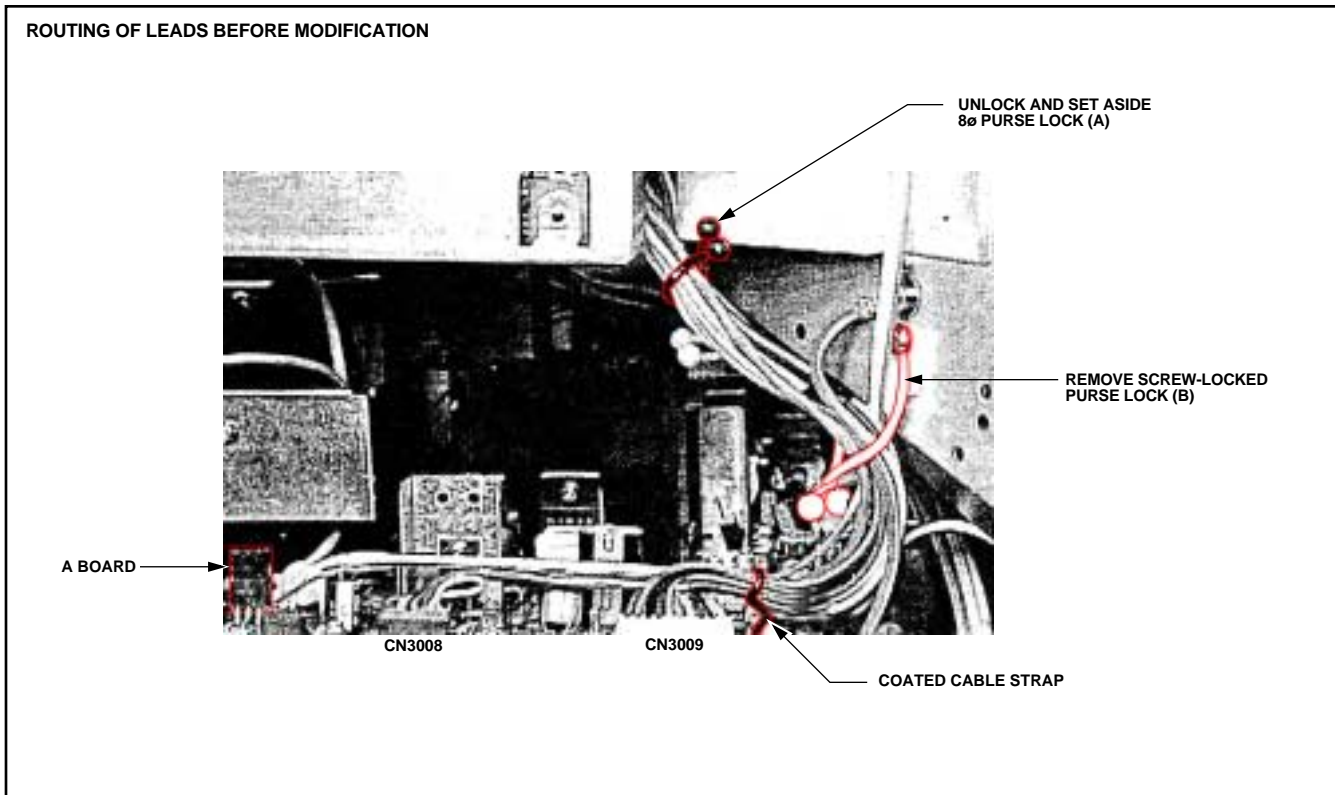
Figure 1

No raster may appear if contact between the A board and connector CN3009 on the A board is poor or lost. This may occur if the receptacle pins of 10-pin connector CN3009 open when the A board is removed or any time the connector lead is pulled or pressed.

A Board (See Figure 1.)

1. Unlock and set aside the floating type (8ø) purse lock (A).
2. Remove the screw-locked purse lock (B) to release the CN3009 connector assembly.
3. Replace the connector assembly with the new one with longer leads.
