Video Products
Technical Bulletin 2000-142

Subject: NOISE AT LEFT SIDE OF PICTURE

WHEN FEEDING SDI SIGNAL

Model: BVM-D14H1E, BVM-D14H1U BVM-D14H5E, BVM-D14H5U

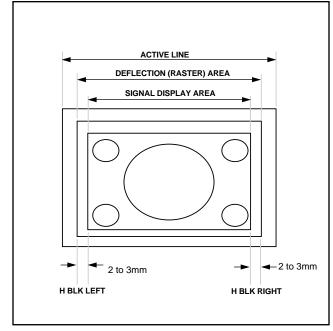
Figure 1

Noise may appear at the left side of the picture when inputting an SDI signal. To correct the symptom, perform the following modification procedure.

- 1. Input a 480/60i monoscope (or cross hatch) signal.
 - **NOTE:** Make sure signal is composite or component. DO NOT input an SDI signal.
- 2. Set UNDERSCAN to ON.
- 3. Increase brightness by adjusting BRIGHT control until blanking is visible on monitor.
- 4. From MAINTENANCE menu, choose DEFLEC-TION menu.
- 5. Adjust H BLK RIGHT as shown in Figure 1.
- 6. Adjust H BLK LEFT.
- 7. Input 575/50i monoscope (or cross hatch) signal.
- 8. Repeat steps 2 through 6.
