Date: January 24, 2000

Model: BKM-103

Subject: PINCUSHION DISTORTION AND GRAY PICTURE

Video Products Technical Bulletin 1999-1 Technical Bulletins for Broadcast and Professional

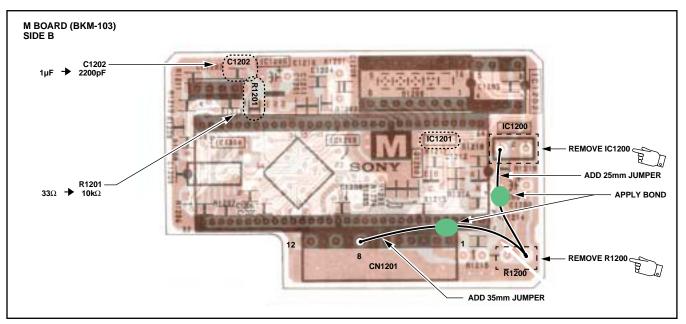
Figure 1

In a monitor with BKM-103 installed, if pincushion distortion and/or gray picture occurs at start-up and disappears when monitor is restarted, perform the following modification procedure.

NOTE: If the CPUs of the monitor and the BKM-103 are started up at the same time, the data in the bus may become corrupt.

BKM-103, M Board Side B (See Figure 1.)

- 1. Replace the following components with new ones:
 - IC1201
 - R1201 (33k $\Omega \rightarrow 10k\Omega$)
 - C1202 (1µF→2200pF)
- Remove resistor R1200 (56Ω).
- 3. Remove IC1200 (5V regulator).
- 4. Solder jumper (35mm) between CN1201 pin 8 and former location of R1200 as shown. Ē
- 5. Solder jumper (25mm) between former locations of IC1200 (OUT) pin 1 and R1200 as shown.
- 6. Apply bond to secure jumper wires to board.
