# Video Products Technical Bulletin 30-2012-114R

SUBJECT: VIDEO DISTURBANCE OR NO VIDEO AT POWER-ON

MODEL: **LMD-1510W**  
**LMD-1530MD**  
**LMD-1530W**  
**LMD-2041W**  
**LMD-2110MD**  
**LMD-2110W**  
**PVM-1741**  
**PVM-2541**

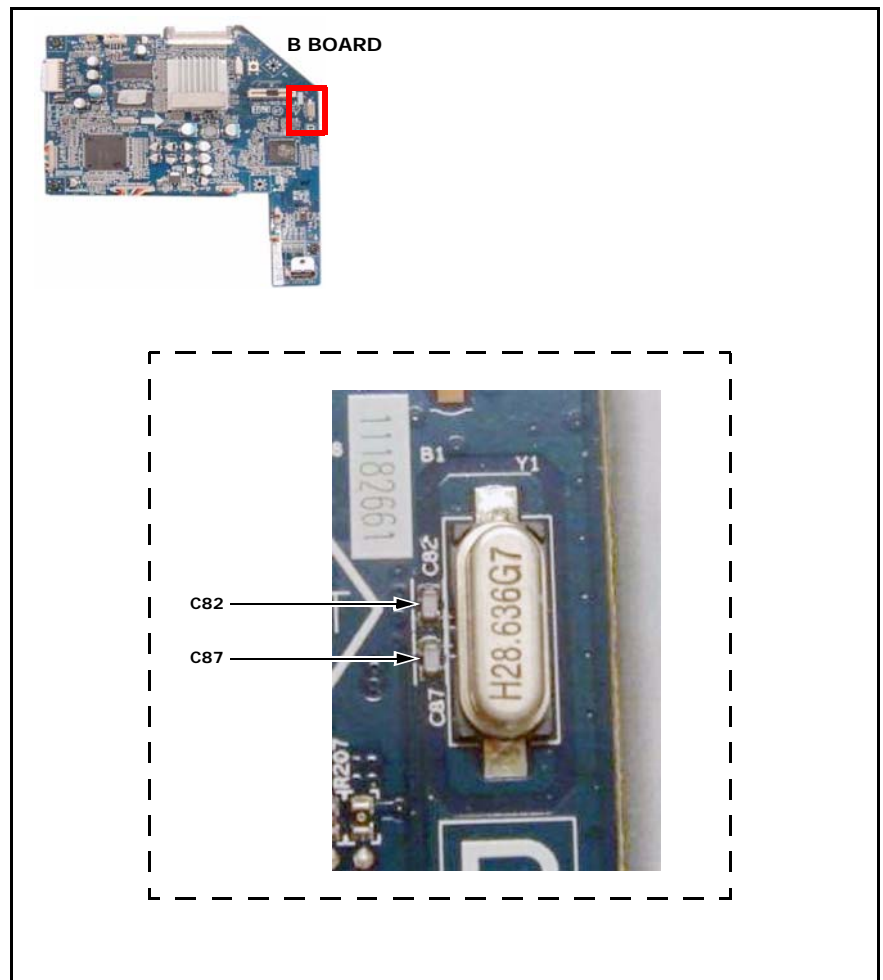
**Figure 1**

When input selection of the monitor is set to HDMI, SDI, or Component, video disturbance or no video may occur at power-ON.

3. Replace C82 and C87 (18 pF) with new 5.6 pF capacitors.  
(See Figure 1.)
