Broadcast Products Technical Bulletin 20-2002-036R

SUBJECT: **NO SDI OUTPUT**

MODEL: **HKPF-103
HKPF-105
HKPF-106
HKPF-103M
HKPF-105M
HKPF-106M**

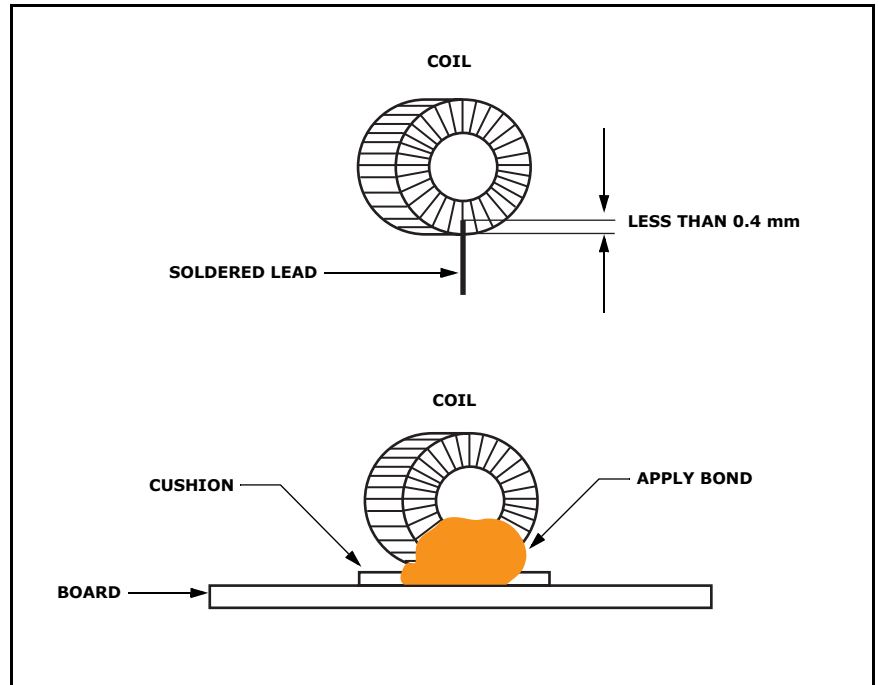
Figure 1

If a short circuit occurs in the toroidal coil winding, the protection circuit of the DC/DC converter is activated and power is not distributed to the circuitry, resulting in no SDI output. The display on the front panel appears as shown in Table 1.

2. If the length of the soldered lead is more than 0.4 mm from the bottom of the coil, replace the coil with a new coil. (See Figure 1.)

3. After inspecting or replacing the coil, affix the coil to the board with bond.

- Perform this step on all units regardless of whether or not the coil is replaced.
 - Allow ten minutes for the bond to harden.
4. Affix the lead, the cushion, and the board together with bond as shown in Figure 1.
