Display

Date: **October 28, 1996**

Subject: **FLASHING IN A GRAY AREA WHEN
USING THE SDI INPUT (BKM-101C)**

Model: **BKM-101C**

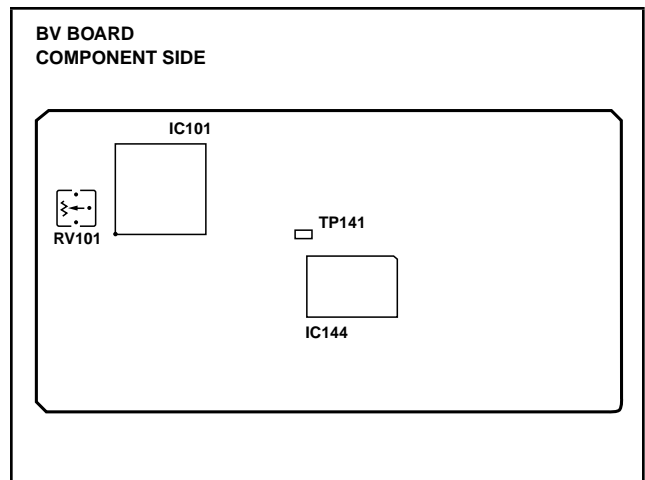
Figure 1

In some units, a flashing may occur in a grey area when a signal is input to the SDI terminal due to out of PLL free-run frequency. If this occurs, perform the following procedure.

BV Board, Component Side (See Figure 1.)

1. Connect a frequency counter to TP141 (zone F-6).
2. Turn on power and wait ten minutes.
3. Adjust RV101 (VCO ADJ) so that the frequency is $13.6\pm 0.1\text{MHz}$.
