**Display**

Date: **April 22, 1996**

Subject: **FLICKER, WHITE BALANCE CHANGE (2)**

Model: **PVM-8040**

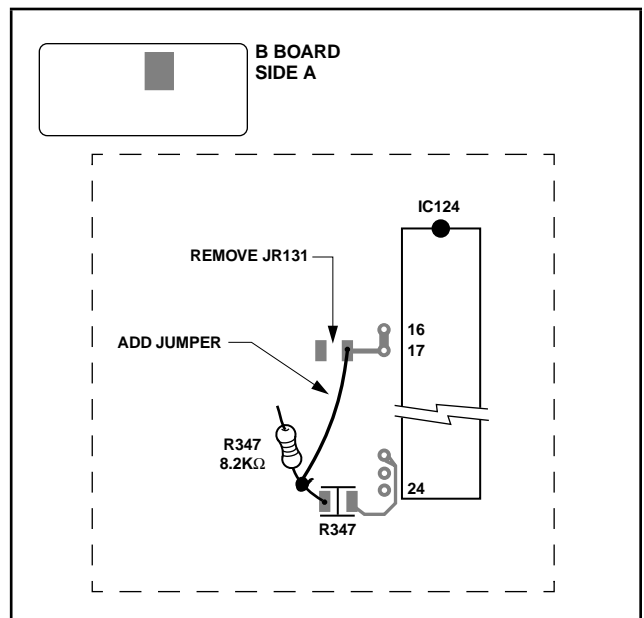
**Figure 1**

In units with S-MIC chassis, when a signal is fed into the current feed-back IC (CX1478S), it may erroneously detect a reference pulse and cause flicker and white balance variations during video reception.

**B Board, Side A (See Figure 1)**

1. Remove 0Ω chip resistor (JR131) (zone C-9, side B).
2. Solder a jumper wire between R347 (zone D-9) and trace leading from IC124-16.

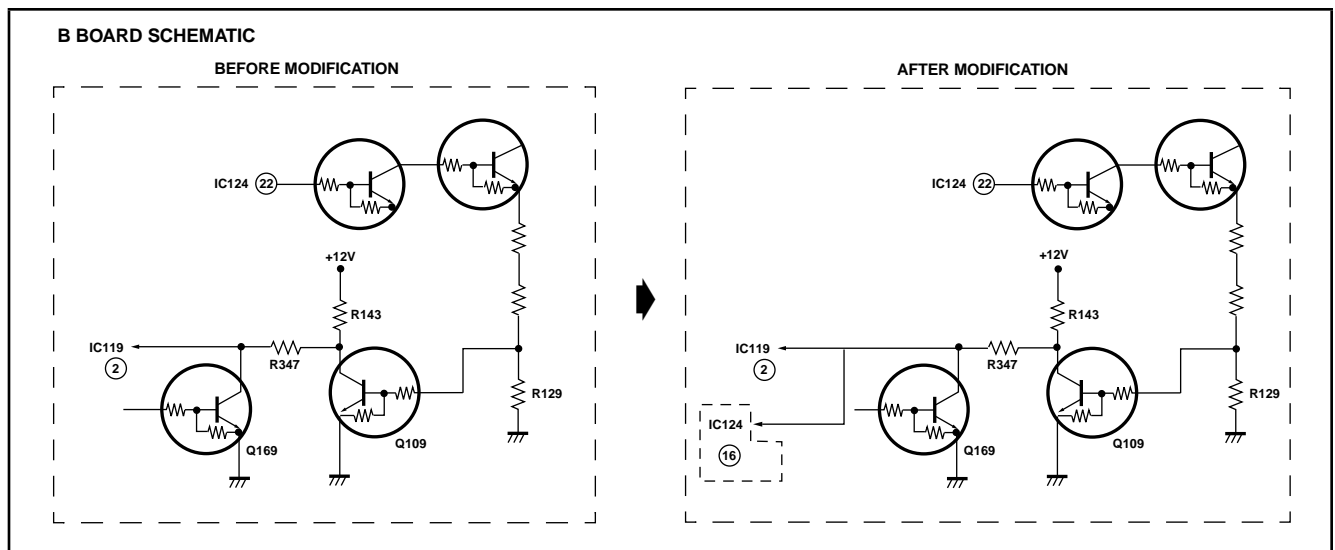
**Figure 2**

The circuit modification is shown on the B board schematic in Figure 2.
