Video Products Technical Bulletin 2000-014 Worldwide Technical Bulletins for Broadcast and Professional Products

Subject: CORRECTING HORIZONTAL STREAKING

Model: BVM-D14H1U, BVM-D14H5U

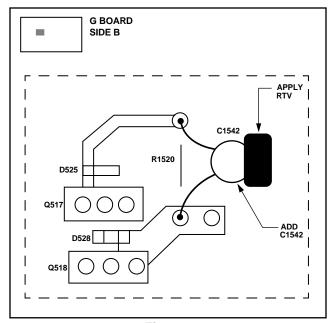
Figure 1

Horizontal streaking noise may appear in a dark scene, at 4:3 normal scan, due to oscillation in the V FOCUS AMP circuit.

1. Solder 330pF capacitor C1542 in parallel with resistor R1520 on G board, suffix -11 and -12 (side B, zone G-3) as shown.

2. Apply RTV to secure capacitor to G board as shown.
