Video Products Technical Bulletin 30-2002-169

SUBJECT: **COLOR CHANGE AT LOW LUMINANCE**

MODEL: ***BVM-F24***
BVM-F24A
BVM-F24U

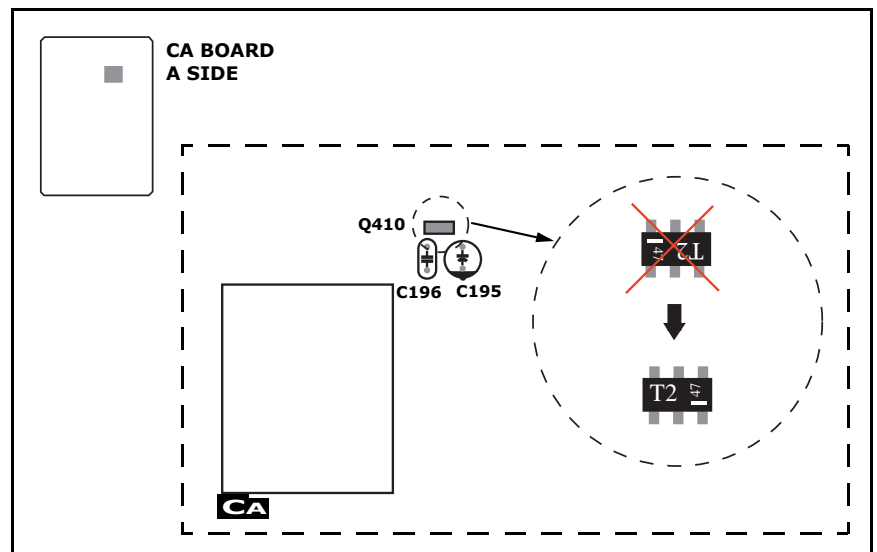
Figure 1

When luminance is low (less than 10 IRE), the color becomes bluish. Even if 100 IRE and 20 IRE are adjusted, the picture does not improve. To correct this condition, perform the following procedure.

CA Board Side A, Zone E-6

On the CA board, replace Q410. Mount the new part as shown in Figure 1.
