Subject: **MINIMIZING HORIZONTAL NOISE**

Model: **PVM-8040/8041Q/8043MD/8044Q**

Serial No: **2,000,001 AND HIGHER**

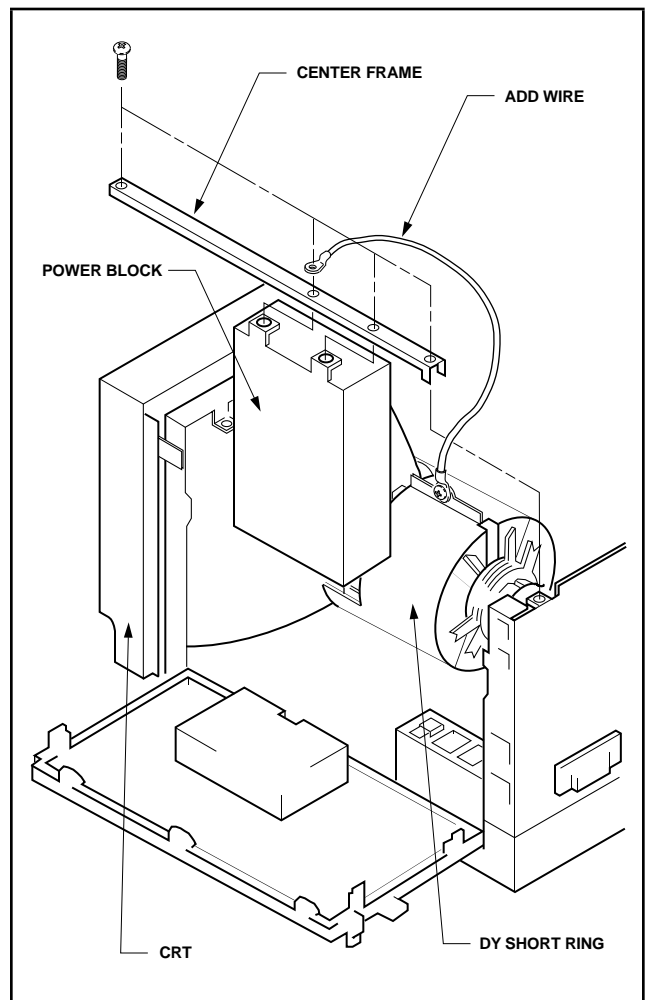
Figure 1

A horizontal noise stripe in the video picture may be the result of an electrical discharge. To correct this condition, a new CRT socket is now available as a replacement part. A complete modification procedure is described below.

MODIFICATION PROCEDURE
CA Board, Solder Side
(See Figure 1.)

1. Replace CRT socket with a new one.
2. Connect G1 terminal to GND.
3. Remove R705 and C702.
4. Solder a 15mm jumper on land vacated by R705.
5. Use RTV silicon glue (part no. 7-322-065-19) to secure the CRT socket to the CRT.
6. Add a wire connecting the DY short ring to the center frame that holds the power block as shown.
7. Tack-solder a 1MΩ resistor between CN507-6 and CN507-8 on the D board.
