# Broadcast Products Technical Bulletin 20-2005-014

SUBJECT: H JITTER DURING NORMAL SCAN

MODEL: ***BVM-D24E1WA***  
***BVM-D24E1WE***  
***BVM-D24E1WU***  
***BVM-D32E1WA***  
***BVM-D32E1WE***  
***BVM-D32E1WU***

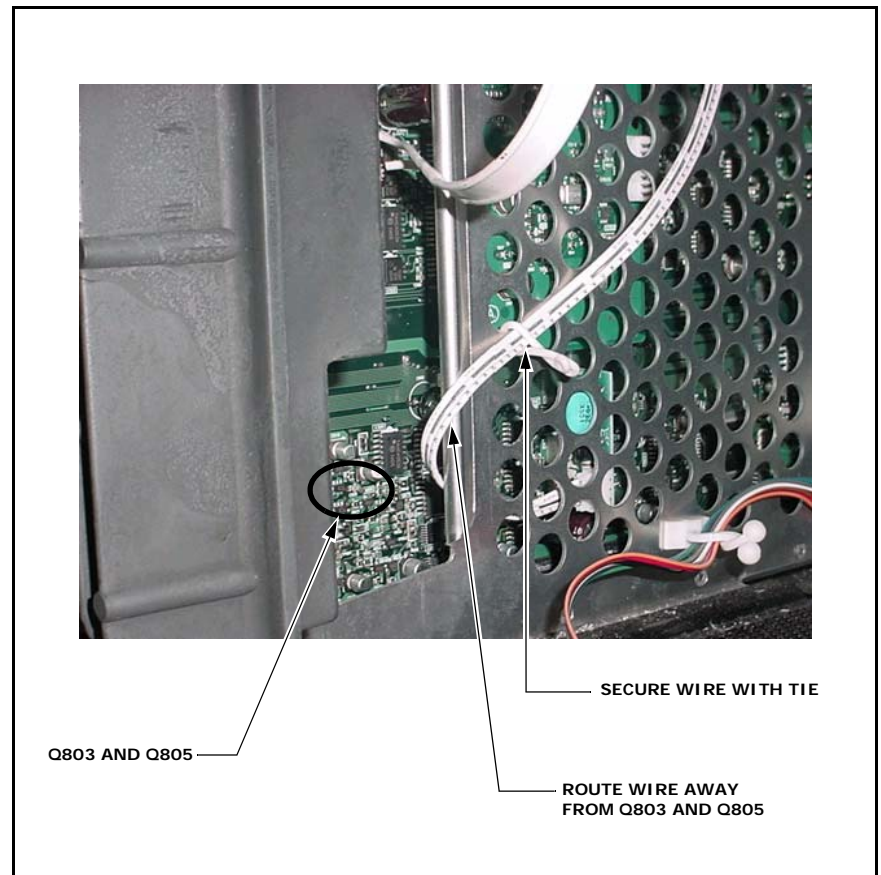
**Figure 1**

H jitter may occur if the wire connecting the BK2 board to the C board is positioned close to the SYNC\_AGC circuit (Q803, Q805) on the BK board.

1. Route the wire away from Q803 and Q805.
2. Secure the wire with a tie or purse lock.
