Subject: **BLACK NOISE OR WHITE NOISE AT D1
 SIGNAL RECEPTION**

Model: **BKM-20D, BKM -21D**

Serial No: **2,000,000–2, 001,730 (BKM-20D)**
2,000,000–2, 004,709 (BKM-21D)

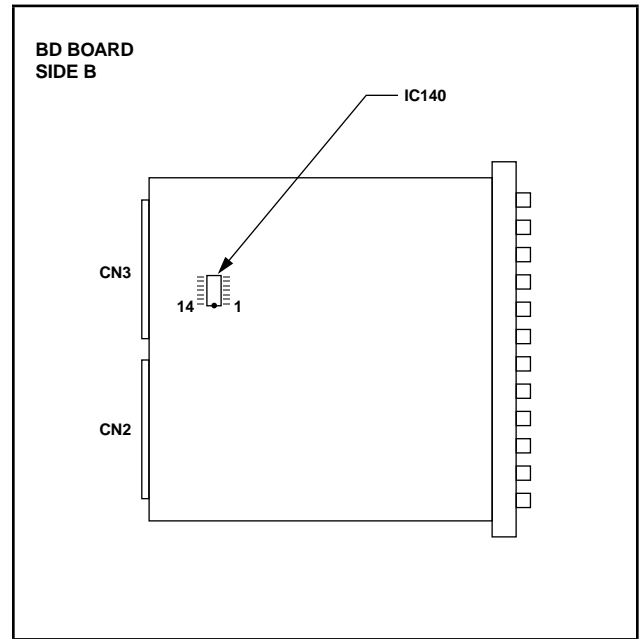
Figure 1

Occasionally, black noise, white noise or speck noise may appear when receiving a D1 signal in a high temperature environment. To correct this, perform the following modification.

1. Remove PCB Shield Assembly from the BD board.
2. Replace IC140 with TC74VHC125F at zone B-2 on the board.
3. No adjustment is necessary (see Figure 1).
