Broadcast Products Technical Bulletin 92-064

Model: BVM-1310/1315/1910/1912/1915

Subject: UNEVEN COLOR IN COMPONENT

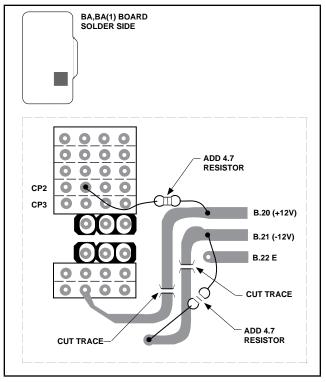
When component input is selected and no video signal is connected, picture color may be slightly inconsistent (e.g., the center may be green while the left and right sides are magenta) when the chroma control on the front panel is set to maximum. The BVM-1315/1915 may also experience ground noise in some high voltage circuits. To minimize these effects, perform the following modification procedures.

MODIFICATION PROCEDURE All Models BA, BA(1) or BA(3) Board Solder Side (See Figure 1 for BA, BA(1) Boards) (See Figure 2 for BA(3) Board)

- 1. Cut trace leading from B20 (+12V).
- 2. Cut trace leading from B21 (-12V).
- 3. Tack-solder two 4.7 Ω resistors (solder side) at locations shown in Figure 1.

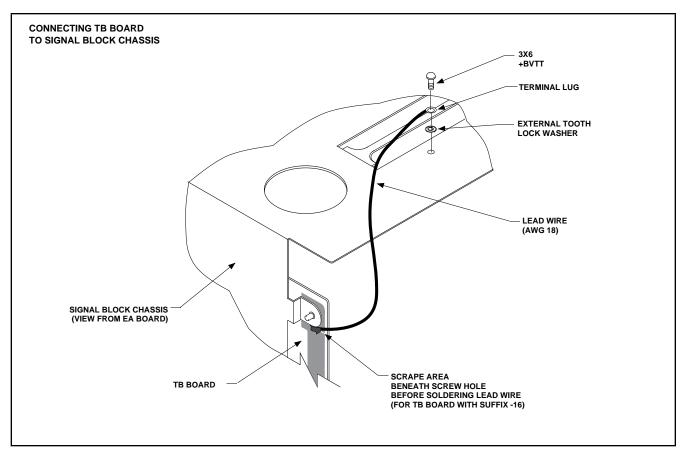
Figure 3

Additional Modification for BVM-1315/1915 (See Figure 3.)

- 1. Connect the TB board to the signal block chassis using a 90mm lead wire (AWG 18) with a 3mm diameter lug on one end. Use a lock washer (7-623-422-07) and 3x6 +BVTT screw to secure the lug to the chassis.
- 2. Solder other end of lead wire to the TB board. On PCB no. 1-617-899-16 (and lower) it will be necessary to lightly scrape the area beneath the screw hole to ensure a reliable connection.
