Subject: **CORRECTING NOISE AND PICTURE LOSS**

Model: **BKM-21D**

Serial No: **2,002,450–2,004,629**

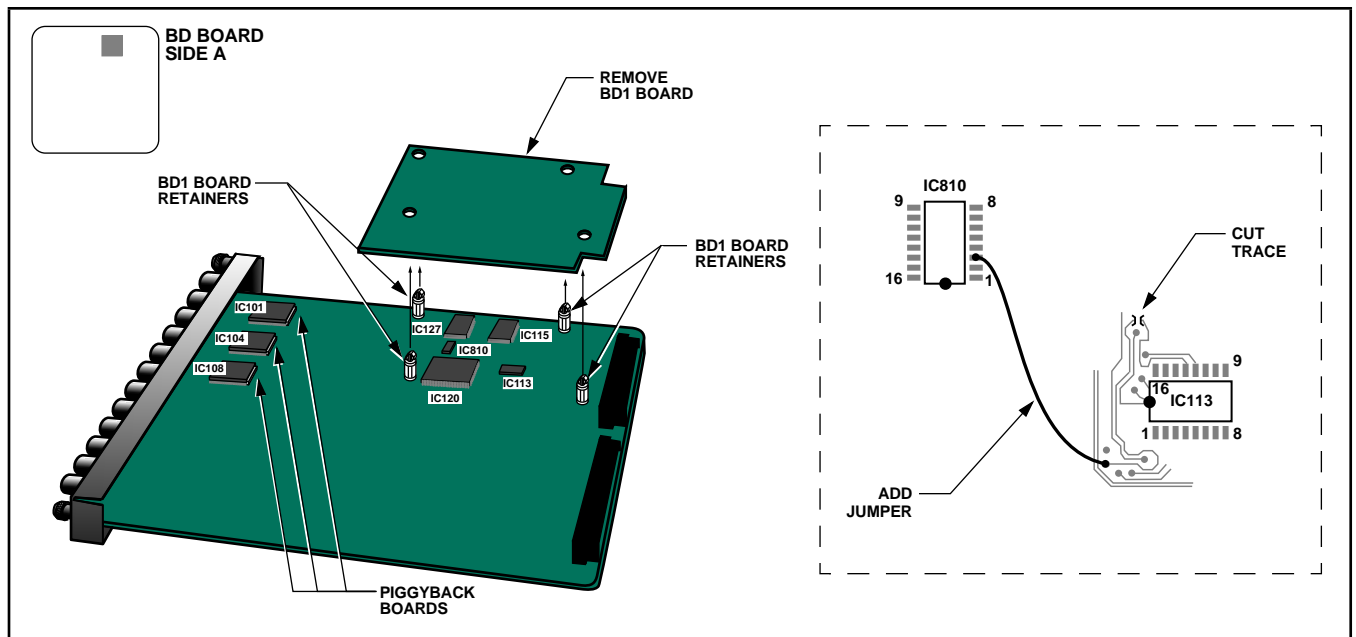
Figure 1

When the unit is installed in a BVM Evergreen Series video monitor and a D2 NTSC signal is received, white horizontal stripe noise may occur or the picture may disappear at startup or in a low temperature environment. In such cases, the piggyback boards beneath IC101, IC104, and IC106 may malfunction.

**BD Board (Side A)
 (See Figure 1.)**

To correct this condition, use the DPR terminal (pin 31) of IC127 (side A, A-12) for detection of SDI signal input, instead of the DPR OUT terminals (pin 23) of IC101, IC104, and IC106, by performing the following modification procedure.

2. Using tweezers or pliers, remove the piggyback BD1 board mounted on the BD board.
3. Cut a trace leading from pin 13 of IC113 (zone B-13) as shown in Figure 1, inset.
4. Solder a jumper between pin 3 of IC810 (zone B-12) and the land near IC113 as shown in Figure 1, inset.
5. Reinstall the BD1 board.
