Date: **June 4, 2001**

Subject: **SPIKE NOISE IN H BLANKING**

Model: **BVM-D20F1A, *BVM-D20F1E*,
 BVM-D20F1U, BVM-D24E1WA
BVM-D24E1WE, BVM-D24E1WU
 BVM-D32E1WA, *BVM-D32E1WE*
 BVM-D32E1WU**

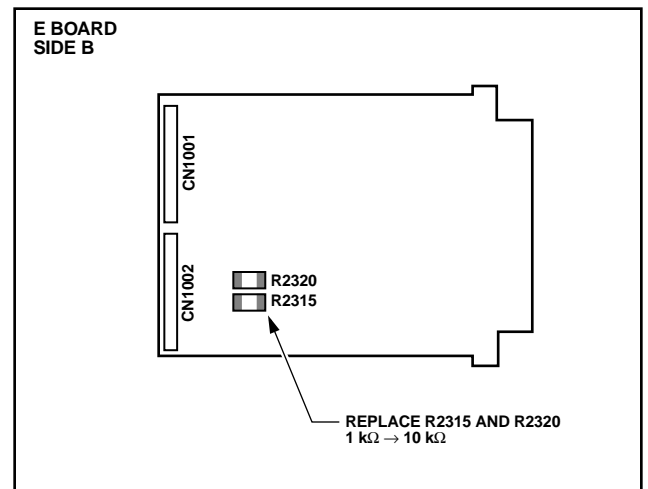
Figure 1

When under-scanned in 1080/60I and 1035/60I mode, spike noise may appear at the left and right in H blanking, appearing to move up and down.

**E Board, Side B
 (See Figure 1.)**

1. Remove the shield plate from the E board.
2. Replace R2315 and R2320 (1 kΩ) with new 10 kΩ resistors.
3. Reinstall the shield plate.
