Video Products Technical Bulletin 30-2004-096

DATE: June 7, 2004 SUBJECT: DAMAGE TO VIDEO OUTPUT IC

MODEL: **PVM-14L5**

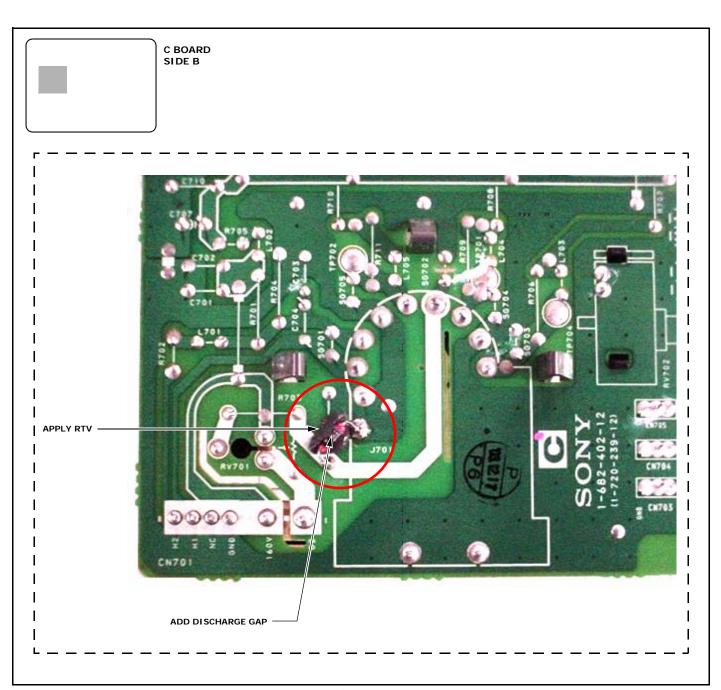
Figure 1

The video output IC (IC701, IC702 and/or IC703) on the C board may become damaged.

NOTE: The modification protects the video output IC from damage due to a voltage surge.

1. Solder a discharge gap between G2 and GND as shown in Figure 1.

NOTE: Maintain a clearance of 1 mm to 7 mm between the discharge gap and the board. Do not allow the discharge gap to touch the board.

- 2. Apply RTV between the discharge gap and the board.
- 3. Perform the modification procedure in Technical Bulletin 30-2003-149 if it has not already been performed.
