Subject: **CORRECTING CRT FLASHING AND
 IRREGULAR WHITE BALANCE**

Model: **PVM-8040/8041Q/8043MD/8044Q**

Serial No: **2,000,001–2,008,300 (PVM-8040)**
2,000,001–2,011,750 (PVM-8041Q)
2,000,001–2,008,100 (PVM-8044Q)
2,000,001–2,000,800 (PVM-8043MD)

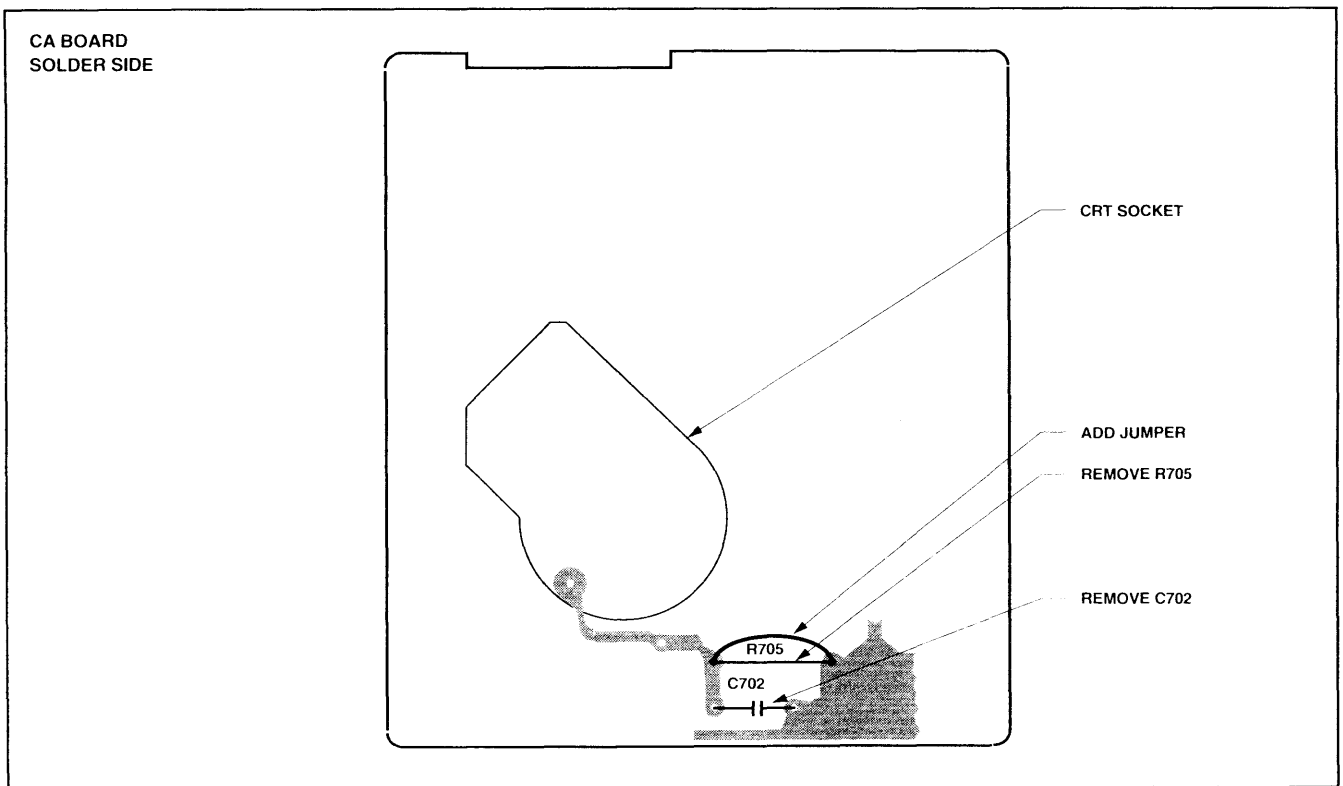
Figure 1

A flashing CRT or an irregular white balance in the video picture may be the result of an electrical discharge in the CRT. To correct this condition, a new CRT socket is now available as a replacement part. Perform the modification procedure described below.

**CA Board, Solder Side
 (See Figure 1.)**

1. Replace CRT socket with a new one.
2. Remove R705 and C702.
3. Solder a 15mm jumper on land vacated by R705.
4. Use RTV silicon glue (part no. 7-322-065-19) to secure the CRT socket to the CRT.

Former	→	New
CRT Socket 1-526-958-41	→	CRT Socket 1-251-244-11
