Date: February 10, 1997

Model: PVM-14N1U/14N2U/20N1U/20N2U

Video Products Technical Bulletin 1996-165R

Subject: BKM-104 BOARD INSTALLATION

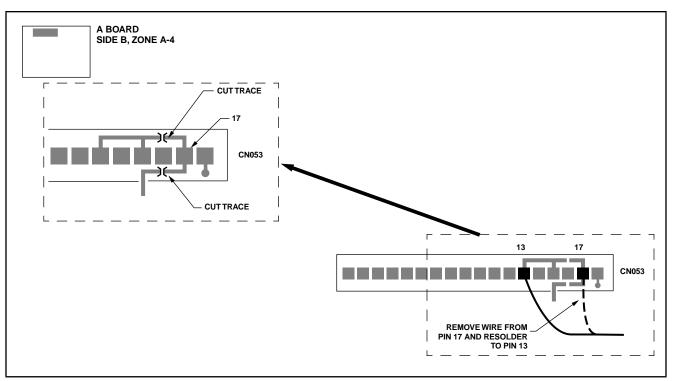
Figure 1

After the BKM-104 caption vision board is installed, CAPTION VISION and the OSD may not display. Due to boards and pin assignments being changed, a short circuit may develop between the display timing signal and ground.

- 1. Remove rear cabinet cover.
- 2. Remove wire soldered to CN053 pin 17 (zone A-4, side B). (See Figure 1.)
- Remove resist and silk print from around CN053 pin 17. Cut traces.
- 4. Solder removed wire, from CN053 pin 17 (step 2), to CN053 pin 13 as shown in Figure 1.
- 5. Remove JW185 and replace with 1SS133 diode. Solder diode, connecting cathode to IC301 side. (See Figure 2.)
- 6. Replace R318 (10k Ω) with 2.2k Ω resistor.
- 7. Solder 250mm wire jumper between the 1SS133 cathode and CN053 pin 17.

NOTE: Route jumper along board edge.
