## Video Products Technical Bulletin 30-2009-041

SUBJECT: DAMAGE TO VIDEO OUTPUT IC

MODEL: PVM-14L5  
PVM-20L5  
PVM-D14L5  
PVM-D20L5

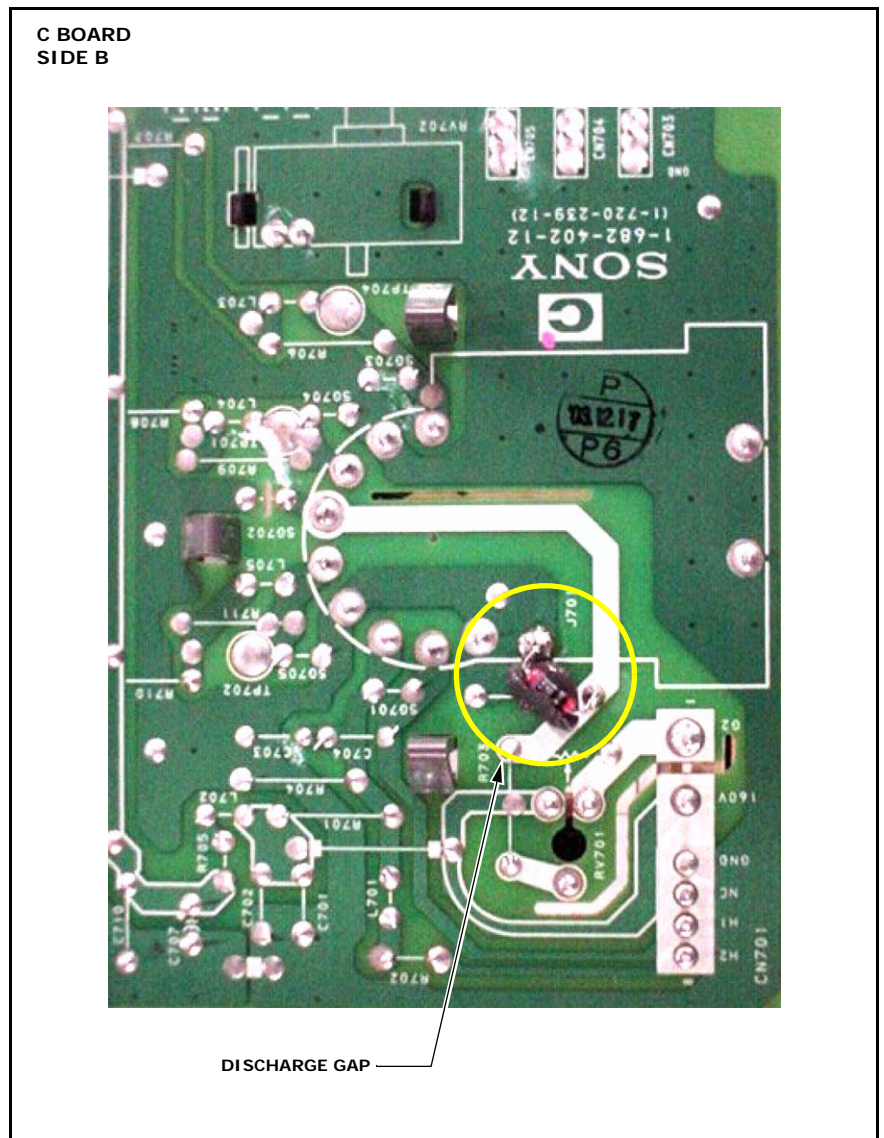
**Figure 2**

The VIDEO OUTPUT IC may be damaged in monitors that have had the modifications described in the following technical bulletins implemented on them:

4. Solder a discharge gap between G2 and GND. If a discharge gap is already installed, replace it with a new one. (See Figure 2.)

**NOTE:** Maintain a clearance of 1 mm or more between the discharge gap and the board, and avoid contact with the board. Maintain a height of 7 mm or less from the board.

5. Secure the discharge gap to the board with RTV.
