# Broadcast Products Technical Bulletin 20-2008-093

SUBJECT: **HARDWARE CHANGES INCLUDED WITH  
VERSION 1.1 SOFTWARE**MODEL: **BVM-L230/1****DESCRIPTION**

BVM-L230/1 2,000,127 and Higher

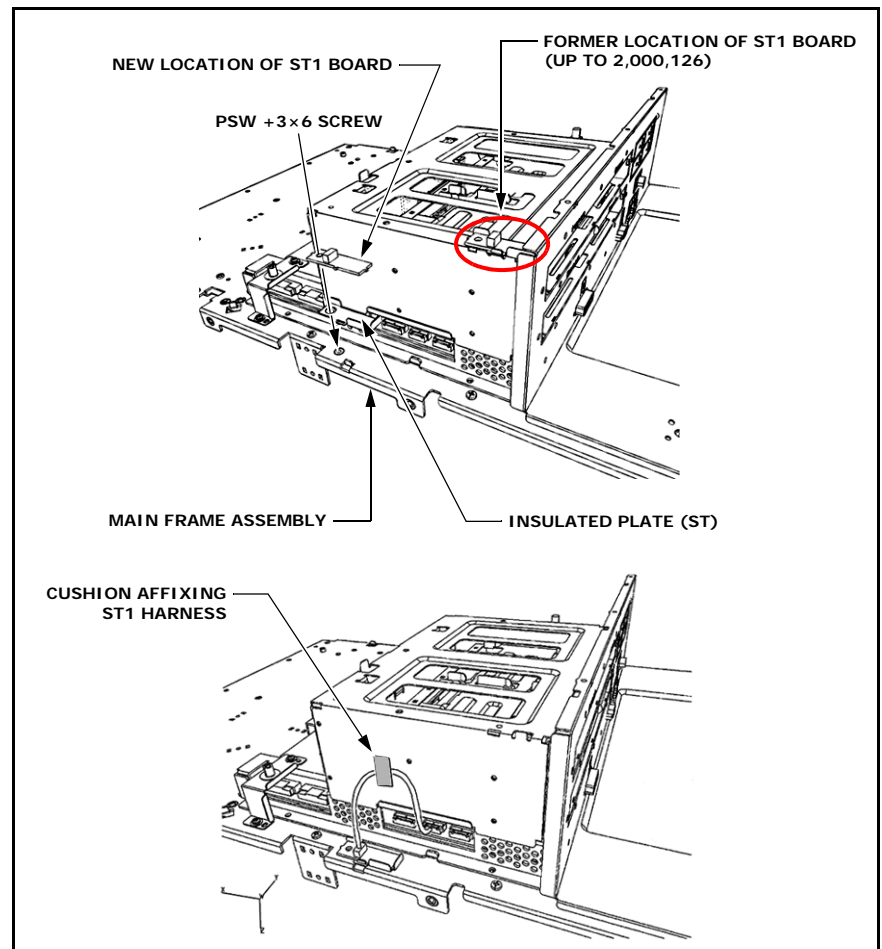
**Figure 1**

- The location of the ST1 board is changed to reduce impact to the temperature sensor with fluctuating set conditions. (See Figure 1.)
- The LVDS harness is routed differently to improve operation. (See Figure 2.)

The new location of the ST1 board is as shown in Figure 1.
