Date: **August 8, 1994**

Subject: **CORRECTING FLICKER AND SMEAR**

Model: **BVM-1310/1311/1315/1316/1316C**  
**BVM-1910/1911/1912/1915/1916/2811**

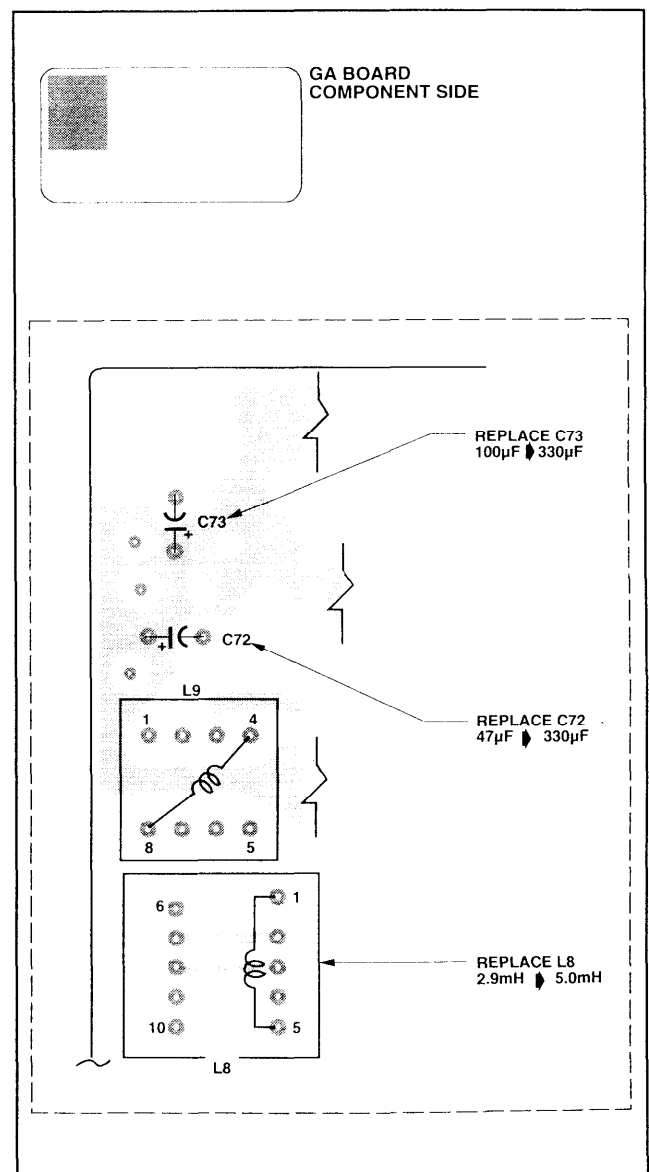
**Figure 1**

When the  $\pm 150V$  input current is reduced, resulting in lowered brightness, some flicker and smear may occur. Additionally, a noise stripe may appear on the screen. To correct these conditions, perform the following modification procedure.

**GA Board, Component Side**  
 (See Figure 1.)

1. Open board cover.
2. Replace L8 with new 5.0mH choke coil.
3. Replace C72, C73 with new 330 $\mu$ F electrolytic capacitors.
