HDVS® Display

Date: **September 13, 1993**

Subject: **HORIZONTAL CONVERGENCE NOISE**

Model: **HDM-2830/3830**

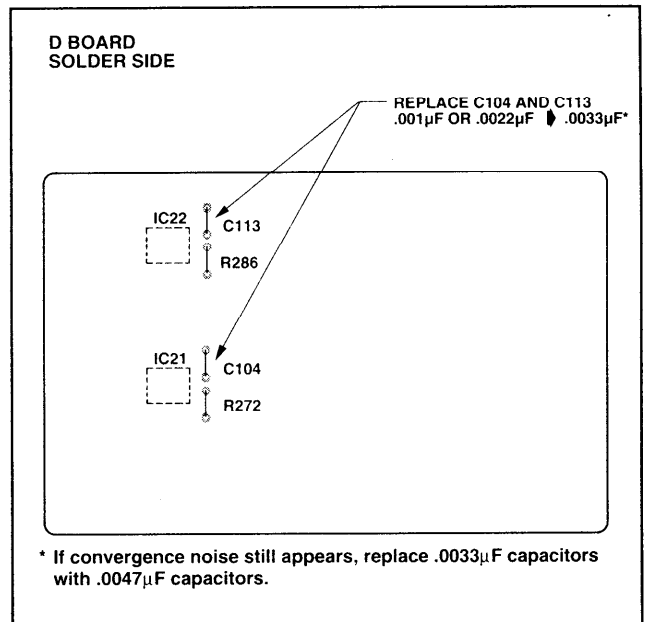
Figure 1

Convergence noise (yellow and/or cyan horizontal lines) may appear in the center of the screen. If this occurs, replace C104 and C113 (.001 μ F or .0022 μ F) on the D board (solder side) with new .0033 μ F capacitors. (See Figure 1.)

NOTE: If convergence noise still appears, replace new .0033 μ F capacitors with new .0047 μ F capacitors.

Since vertical convergence of all corners will also be affected, readjust both vertical and horizontal convergence after replacement of these capacitors. Refer to the appropriate Operation and Maintenance Manual.
