Video Products Technical Bulletin 30-2001-107R

DATE: **March 24, 2003**SUBJECT: **WHITE VERTICAL LINE NOISE IN BLANKING**

MODEL: **BVM-D24E1WA**
BVM-D24E1WE
BVM-D24E1WU
BVM-D32E1WE
BVM-D32E1WU

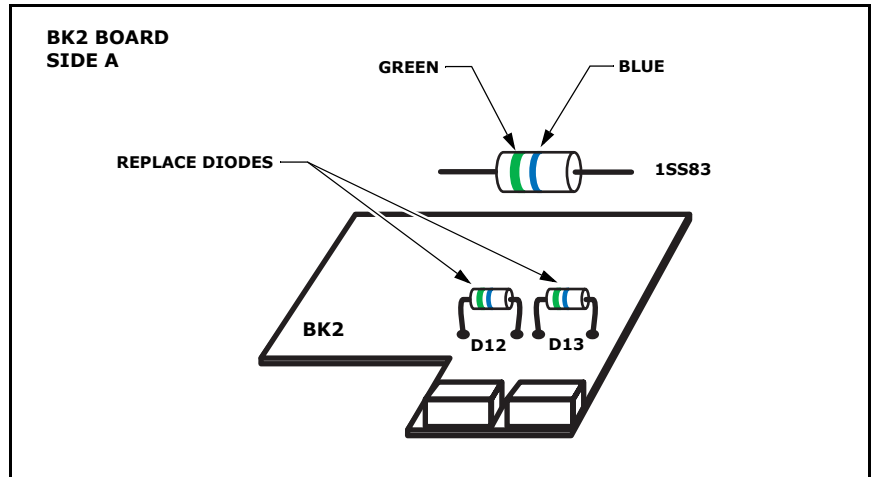
Figure 1

When decreasing the BRIGHTNESS control in a dark scene, if faint white vertical lines are visible in the blanking portion (left side), perform the following modification procedure.

**MODIFICATION PROCEDURE****BK2 Board (Piggyback Board on BK Board)****Side A**

1. Replace D12 and D13 with new 1SS83 diodes. (See Figure 1.)

NOTE: Observe correct polarity.

2. Replace R14 (3.3 kΩ) with a new 10Ω resistor.
