Display

Subject: **CORRECTING UNEVEN BRIGHTNESS**

Model: **BVM-8044/9044/9044D**

Serial No: **2,000,001–2,000,200 (BVM-8044)**
2,000,001–2,000,070 (BVM-9044)
2,000,001–2,000,400 (BVM-9044D)

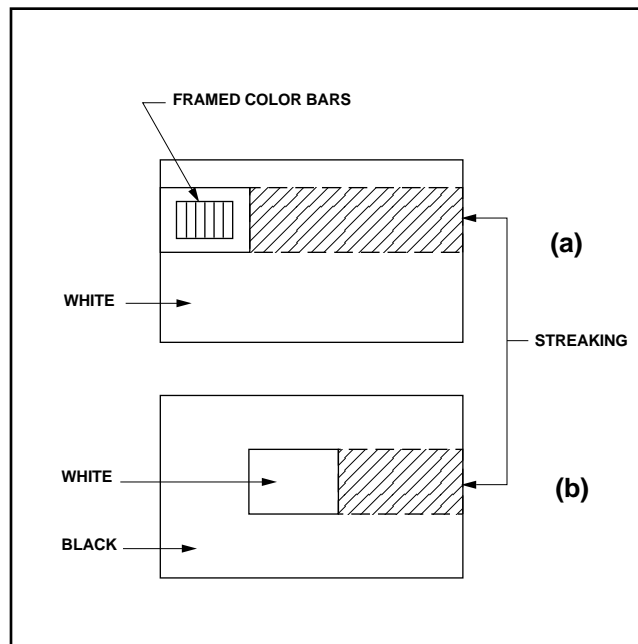
When an SDI signal is input, picture brightness may undulate or appear streaked. This effect may occur in

- the white area to the right of framed color bars as shown in Figure 1 (a), or
- the black area to the right of a white window as shown in Figure 1 (b).

To minimize this condition, perform the following modification procedure.
