Video Conferencing

Date: **November 17, 1997**

Subject: **FIRMWARE UPGRADE—VERSION 3.10**

Model: **PCS-4000, PCS-5000, PCS-5100**

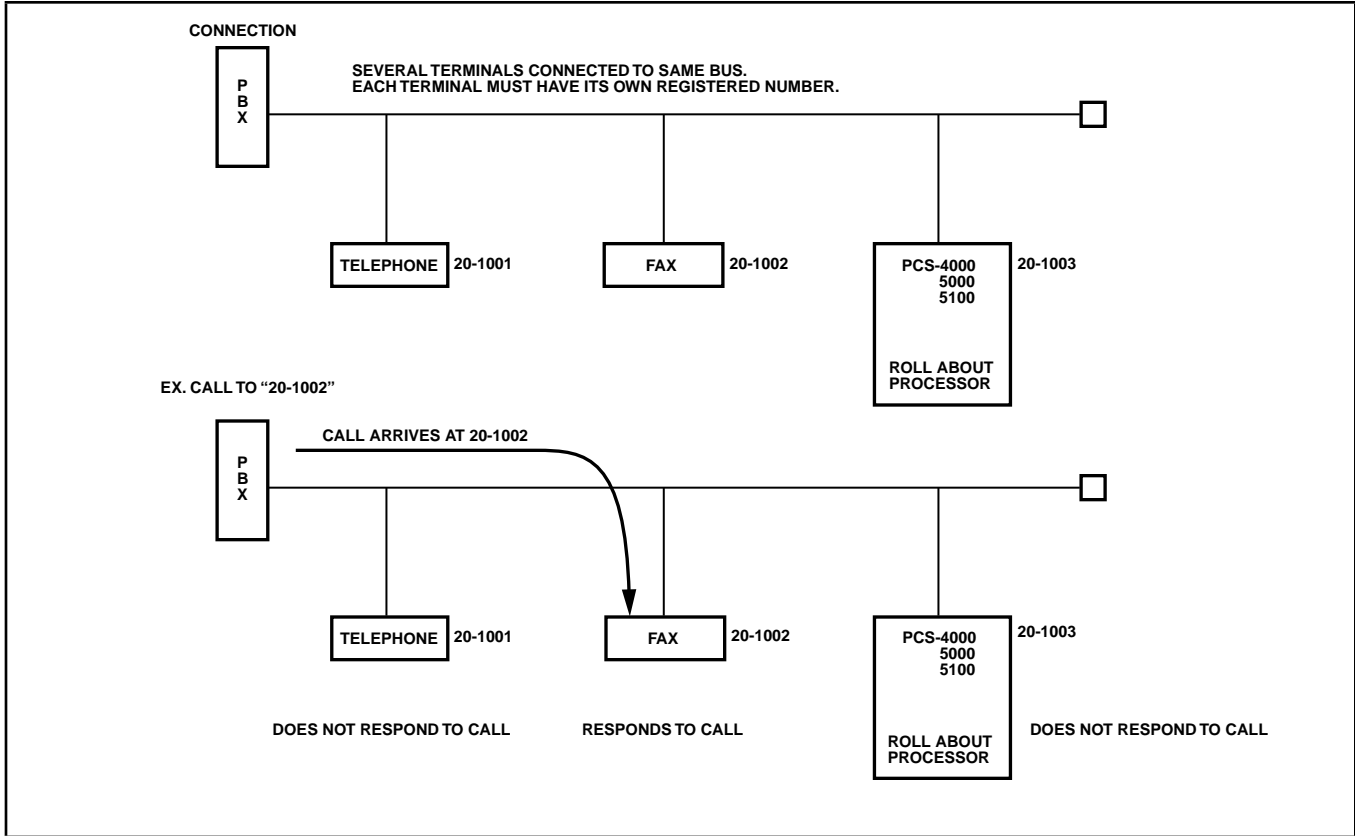
Figure 1

1. Multiple Subscriber Number Function is now supported in which a network provides different line numbers to several ISDN terminals connected to the same bus. In this version, the correct incoming call is responded to. In the previous version, a line number received from the network was not identified with an LDN (local directory number) registered in that line's terminal. Therefore, sometimes a call other than one from that terminal was responded to. (National ISDN-1 in USA did not experience this problem.) (See Figure 1.)

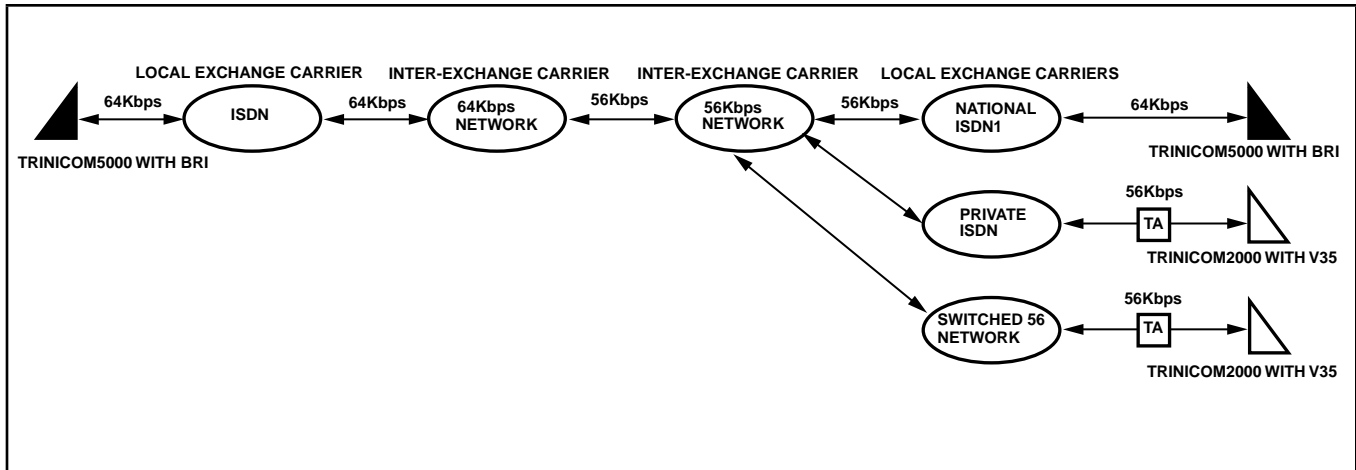
Figure 3

7. PCS-2000 Connection—The following have been corrected. (See Figure 3.)

- When connected to a PCS-2000, a camera at the end of the line could not be controlled from the "EASY MENU" in the PCS-5000.
- When making a mutual connection of a PCS-2000 in 56 kbps and a PCS-5000 in 64 kbps ISDN, audio and video were not output.
