Date: **October 23, 2000**

Subject: **LOSS OF WHITE BALANCE**

Model: **OEV-142, OEV-143, OEV-202, OEV-203**
PVM-1353MD, PVM-1450MD, PVM-1453MD
PVM-14M2MDE, PVM-14M2MDU
PVM-1953MD, PVM-2053MD
PVM-20M2MDE, PVM-20M2MDU

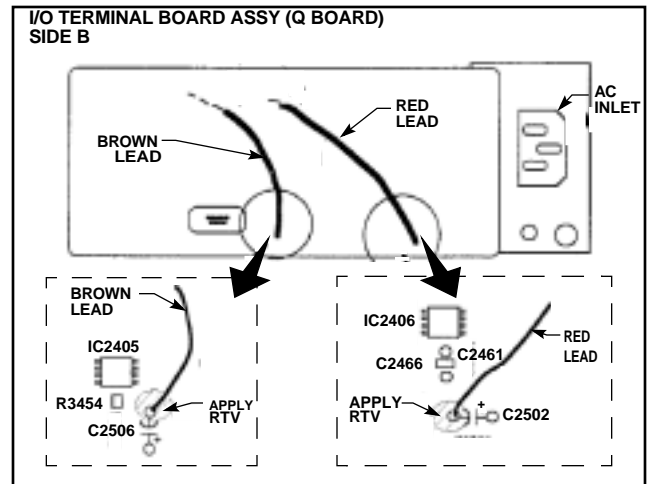
Figure 1

The input/output terminal board may warp when mounted, causing poor contact in the 75Ω termination switch. As a result, the signal level becomes unstable, and white balance is lost.

NOTE: When replacing the former input/output terminal assembly, P/N 1-537-877-11, with the new part, P/N 1-537-877-15, remove the soldered 2-pin connector harness from the former (suffix -11) board and install it on the new (suffix -15) board (side B) as follows and as shown in Figure 1:

1. Solder brown lead of connector harness to negative lead of capacitor C2506.
2. Solder red lead of connector harness to negative lead of capacitor C2502.
3. Apply RTV as shown.
