Video Products Technical Bulletin 30-2003-096

DATE: March 24, 2003 SUBJECT: V JITTER AT H/V DELAY

MODEL: PVM-14L4

PVM-14L3 PVM-20L4

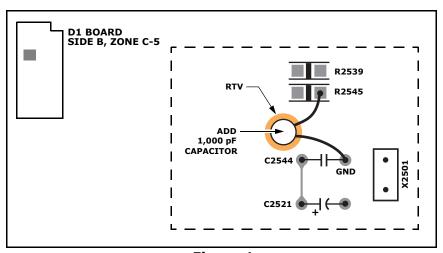
Figure 1

Noise may enter V.SYNC at H/V delay, which may destabilize the delay time of IC2504, causing V jitter. To correct the symptom, perform the following modification procedure.

D1 Board (Side B, Zone C-5)

1. Add a 1,000 pF capacitor between ground and the junction of R2545 and C2513 (1 μ F/10V) of the input to IC2504. (See Figure 1.)

2. Affix the capacitor to the board with RTV.

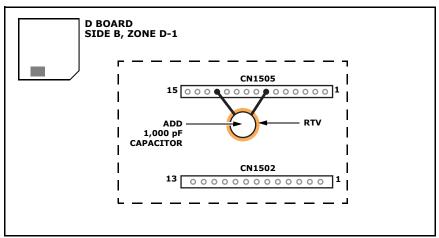
Figure 2

D Board (Side B, Zone D-1)

If the part number of the D1 board is 1-682-404-11, modify the D board as follows:

1. Add a 1,000 pF capacitor to CN1505 between pins 12 and 7. (See Figure 2.)

2. Affix the capacitor to the board with RTV.
