Date: **July 19, 1993**

Subject: **COLOR INVERSION**

Model: **BKM-2085-14, BKM-2085-20**

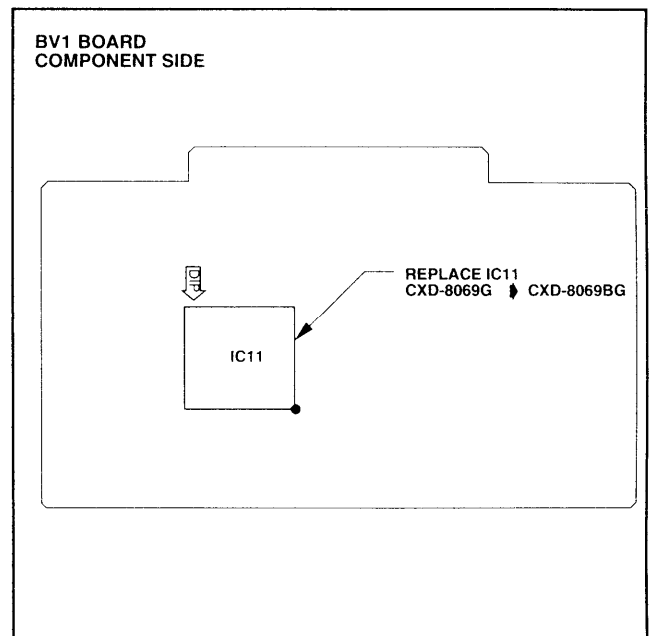
Figure 1

Color inversion may occur if nonsynchronized signals are switched and input through the serial digital video decoder (IC11) on the BV1 board. If this occurs, replace IC11 (CXD-8069G) on the BV1 board with upgraded IC type CXD-8069BG. (See Figure 1.)

NOTE: If a jumper wire is installed between pins 32 and 62 of IC11 (CXD-8069G) on the BV1 board, remove it when replacing IC11; do not reinstall it.
