CLD-A100

SERVICE INFORMATION

No. : SI-V48056

CLD-A100 LaserActive

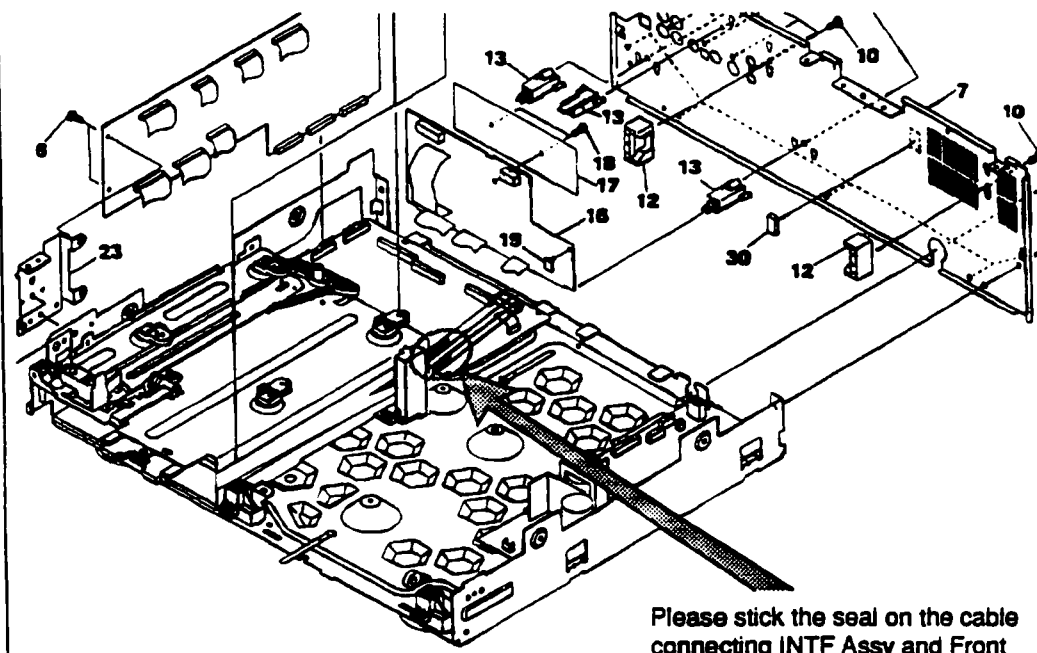
#	REASON FOR CHANGES
1	Addition of seals to the flexible cable
1	To protect the cable from burrs on its cable

Please stick the seal on the cable connecting INTF Assy and Front Panel near the core holder

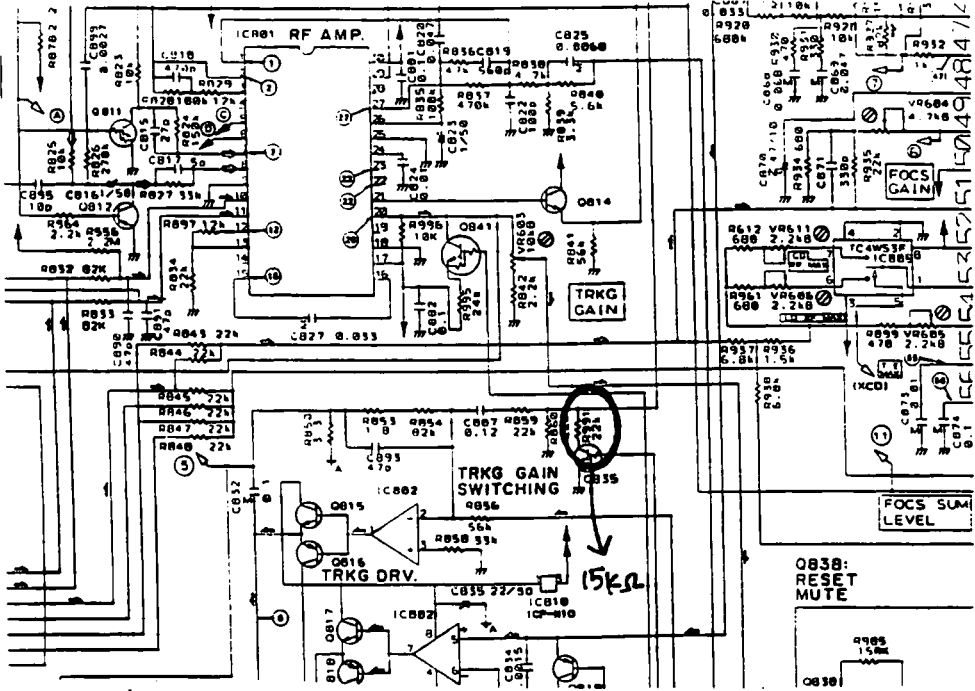
#	DETAIL OF CHANGE(S)	#	REASON FOR CHANGES
1	Change of a resistor in FTSB Assy	1	To improve playability

Ref.	CURRENT PARTS		CO	NEW PARTS	
	#	SYMBOL/DESCRIPTION		DE	PART NUMBER
A	1	R991(22kΩ)	2	RS1/108153J	R991(15kΩ)

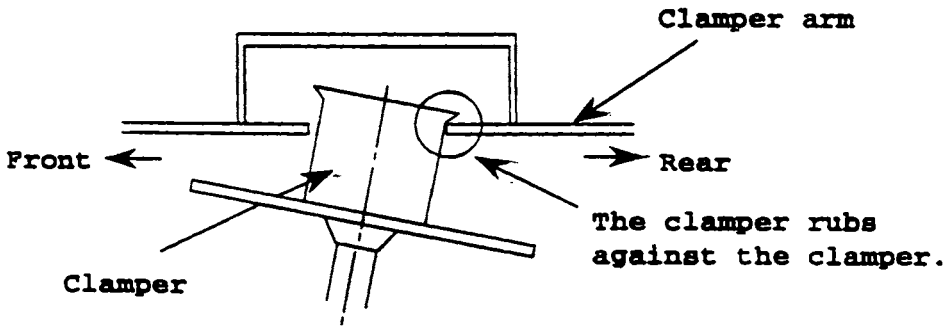
[Fig. 1]

<PROBLEM> Mechanical noise is audible when an LD disc is played.

<CAUSE> When an LD disc is clamped, the motor center axis is slanted due to:

- The height of the mech mounting portions on the Chassis is lower by 0.5mm.
- The mounting position of the mechanism is deviated toward the rear side.

Therefore, the clamber rubs against the clamber arm at the rear side.

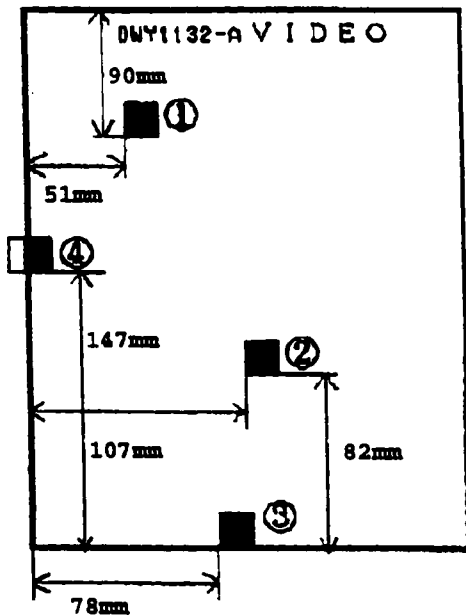
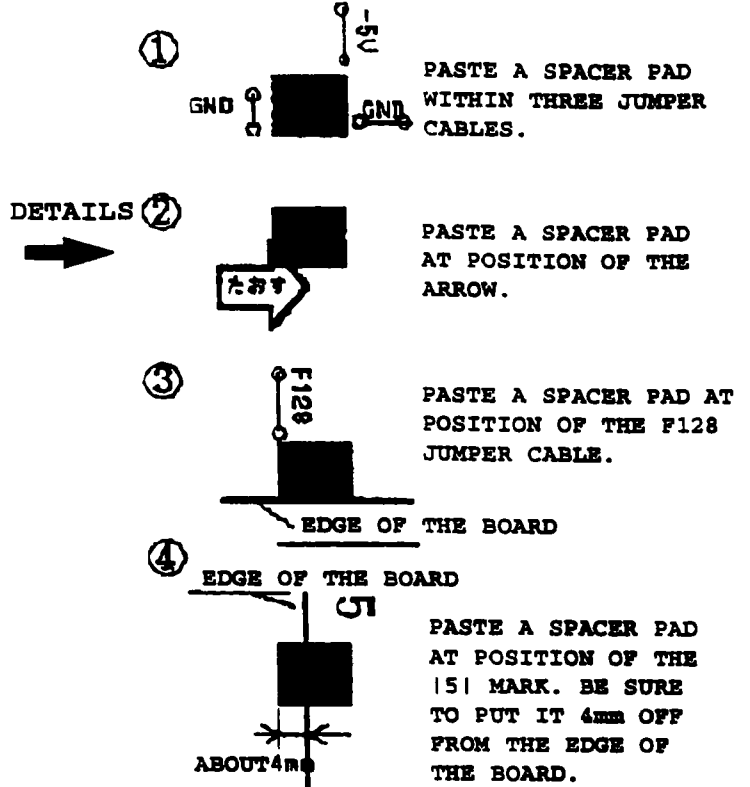
FIG.3:VIDEO ASS'Y-PARTS MOUNTED SIDE

<PROBLEM> THE 12 INCH DISC GETS SCRATCHED WITH A CIRCULAR MARK.
 <CAUSE> DUE TO CLOSE DISTANCE BETWEEN THE DISC AND VIDEO ASS'Y IN THE DISC CLAMPED STATUS, PARTS (CAPACITORS, ETC.) MOUNTED ON VIDEO ASS'Y CONTACT WITH THE DISC WHEN A SHOCK IS APPLIED TO THE UNIT DURING PLAYBACK, CAUSING A CIRCULAR SCRATCH ON THE DISC.

<SERVICE REMEDY> PLEASE ADD FOUR SPACER PADS ON THE PARTS MOUNTED SIDE OF VIDEO ASS'Y TO PREVENT A SIGNAL RECORDED AREA OF THE DISC FROM BEING SCRATCHED WITH A PROTECTIVE CONTACT OF THE DISC EDGE WITH THE SPACER PADS.

*NOTE (1) PLEASE LOCATE A SPACER PAD WITHIN $\pm 1.0\text{mm}$ IN TOLERANCE.

(2) AFTER PASTING A SPACER PAD ON THE BOARD, PLEASE APPLY THE SILICONE ADHESIVE (GYL-1002) AT TWO POSITIONS OF THE PAD AS SHOWN RIGHT. ALSO, PLEASE ASSEMBLE BOARDS INTO THE UNIT AFTER THE ADHESIVE GETS DRY.

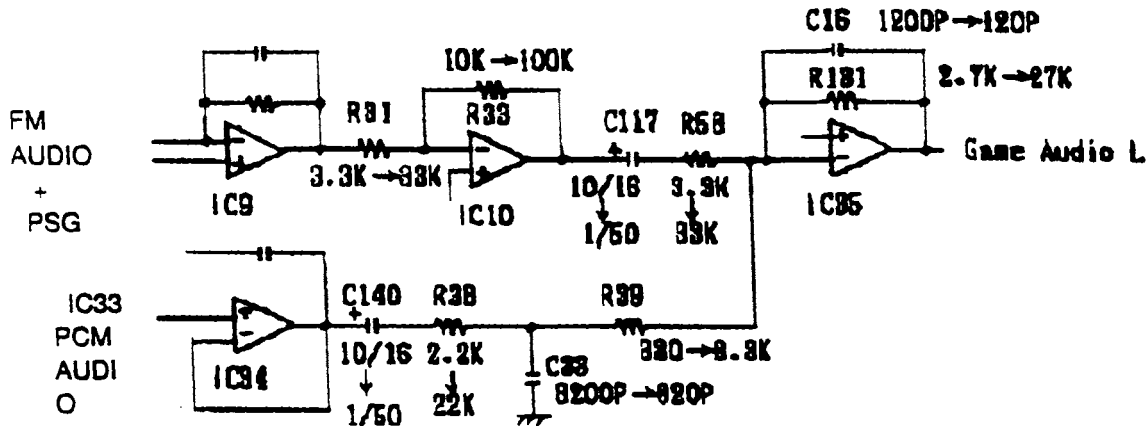
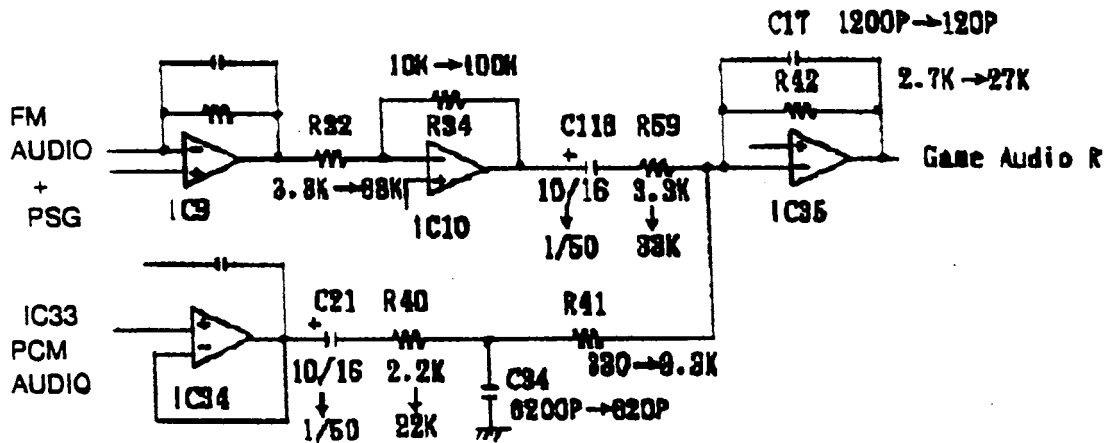
[FIG.1: AUDIO MIX CIRCUIT OF SSUB ASSY]

<PROBLEM> WHEN A CERTAIN SEGA GAME SOFTWARE IS PLAYED, HIGH FREQUENCY AUDIO IS DISTORTED.

<CAUSE> IN CASE THE RECORDING LEVEL OF A SEGA GAME SOFTWARE IS HIGH IN AUDIO, AUDIO OUTPUT FROM OP-AMP (SSUB ASSY:IC10) IS DISTORTED DUE TO HIGH CURRENT OPERATION OF THE AUDIO MIX CIRCUIT.

PLEASE MODIFY THE AUDIO MIX CIRCUIT AS SHOWN BELOW.
