Subject: **VERTICAL LINE**

Model: **HDM-2830**

Serial No: **2,100,036 AND HIGHER**

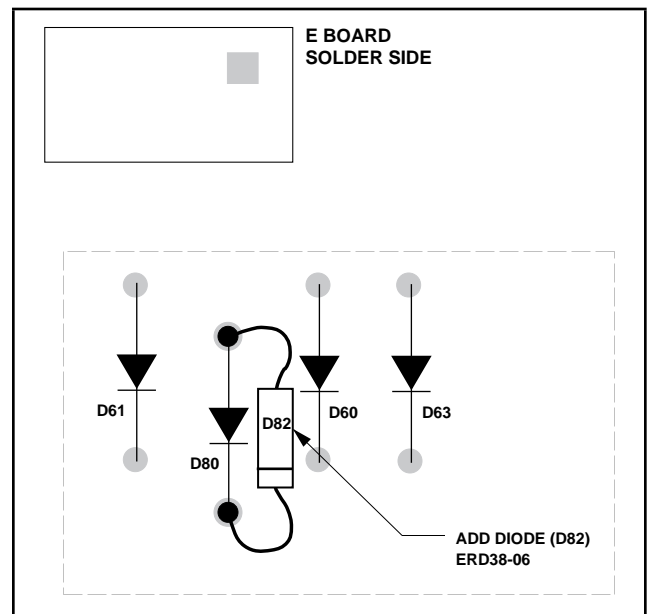
Figure 1

A brighter vertical line may sometimes appear near center of the display image. To correct this, modify the E board by soldering a ERD38-06 diode in parallel to D80 as shown in Figure 1. Ensure that the cathode of the new diode is at least 2mm away from D63, and affix the diode to the board with RTV.

Part No.	Description	Qty.
8-719-939-07	Diode ERD38-06	1
