Date: **June 7, 1999**

Subject: **CORRECTING BLACK HORIZONTAL STRIPE NOISE**

Model: **BVM-8044QD, BVM-8045QD**
PVM-8040, SSM-8040

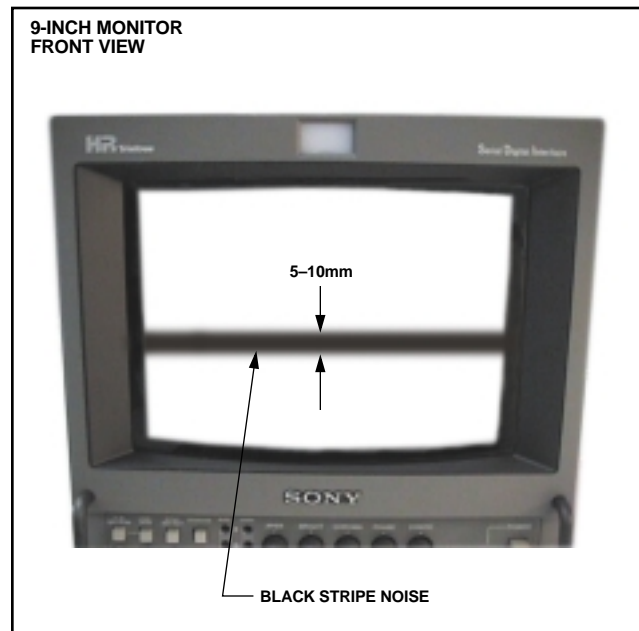
Figure 1

If the high voltage cable retaining disk touches inductor L506 on the D board, 5 to 10mm wide black stripe noise may periodically appear on the 9-inch monitor screen for 0.1 to 0.2s. (See Figure 1.)
