Video Products Technical Bulletin 30-2005-023

SUBJECT: NO PICTURE IF ANODE CAP COMES OFF

MODEL: ***PVM-9L1***
PVM-9L1**DESCRIPTION**

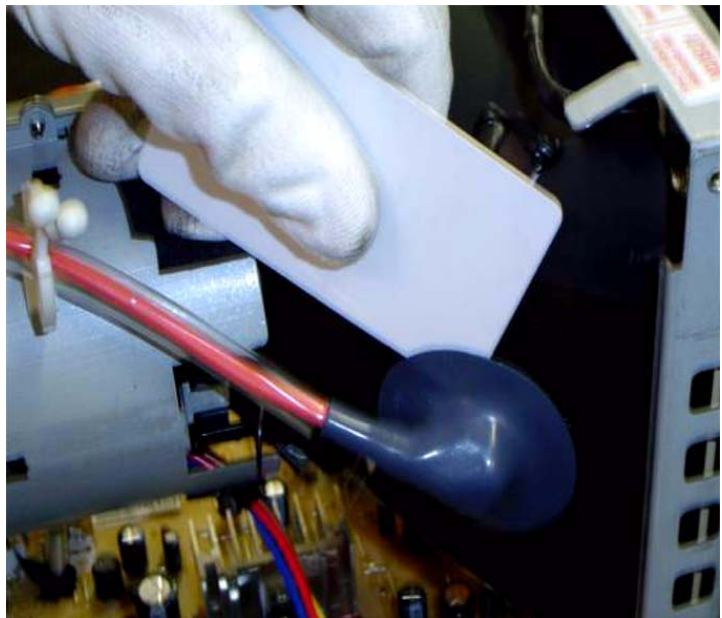
Figure 1

1. Insert a card or equivalent under the anode cap. (See Figure 1.)

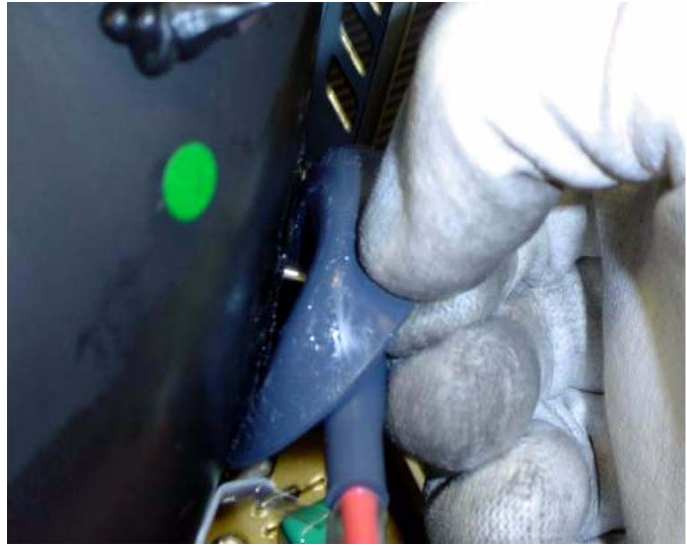
Figure 2

2. Turn over the anode cap to check that both locking clips are inserted securely into the anode button of the CRT. (See Figure 2.)

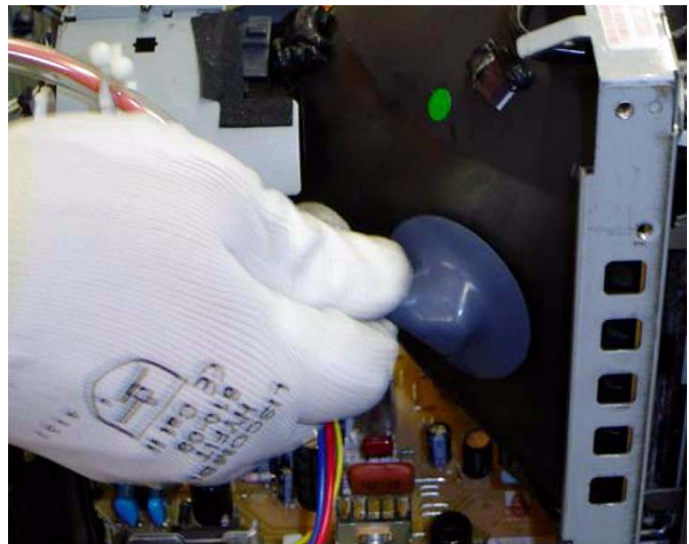
Figure 3

3. If the clips are not inserted securely, insert them.
4. Confirm that the anode cap is attached securely by pushing and pulling it. (See Figure 3.)
