Subject: **BLACK HORIZONTAL STRIPES AT POWER ON**

Model: **PVM-1351Q/1354Q/1353MD**

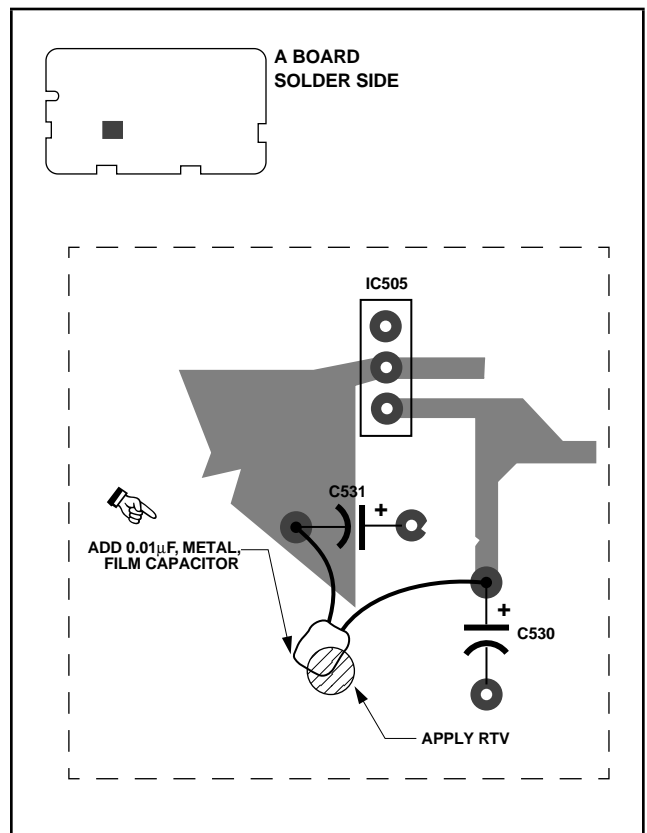
Figure 1

At low temperature, four or five black, horizontal stripes may appear in the center of the screen, at power on, then disappear when the unit warms up. This occurs due to a disturbance in vertical deflection.

To correct such an occurrence, solder the metal capacitor listed in the parts required table below to capacitors C530 and C531 on the A board (solder side, zone F-4), as shown in Figure 1. Apply RTV to secure the metal capacitor to the board.
